**ACCELERATOR LABORATORY**  
**ADVANCED RESEARCH CENTER FOR BEAM SCIENCE**  
**INSTITUTE FOR CHEMICAL RESEARCH**  
**KYOTO UNIVERSITY**

# Development of High Resolution Camera and Observations in TESLA Cavities

Y. Iwashita, Y. Tajima and H. Hayano

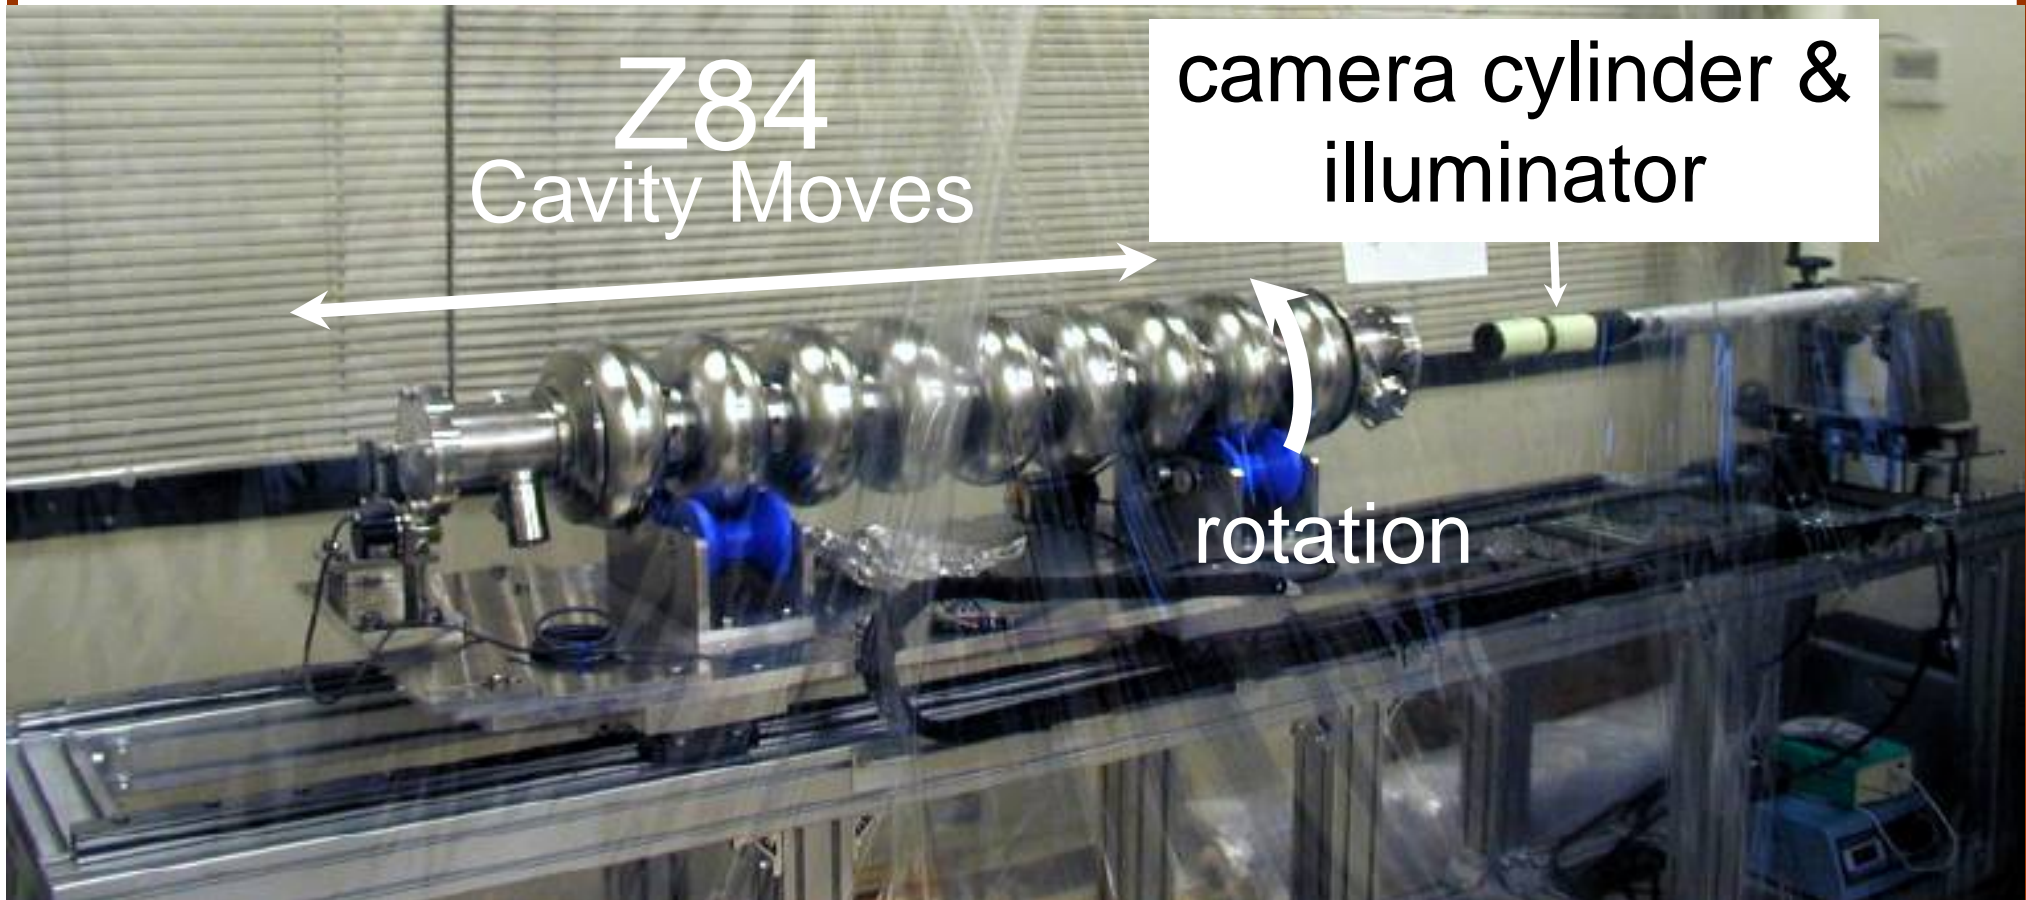
# Early System

Cavity is rotated and moved longitudinally.  
The cavity moves to swallow the camera cylinder.

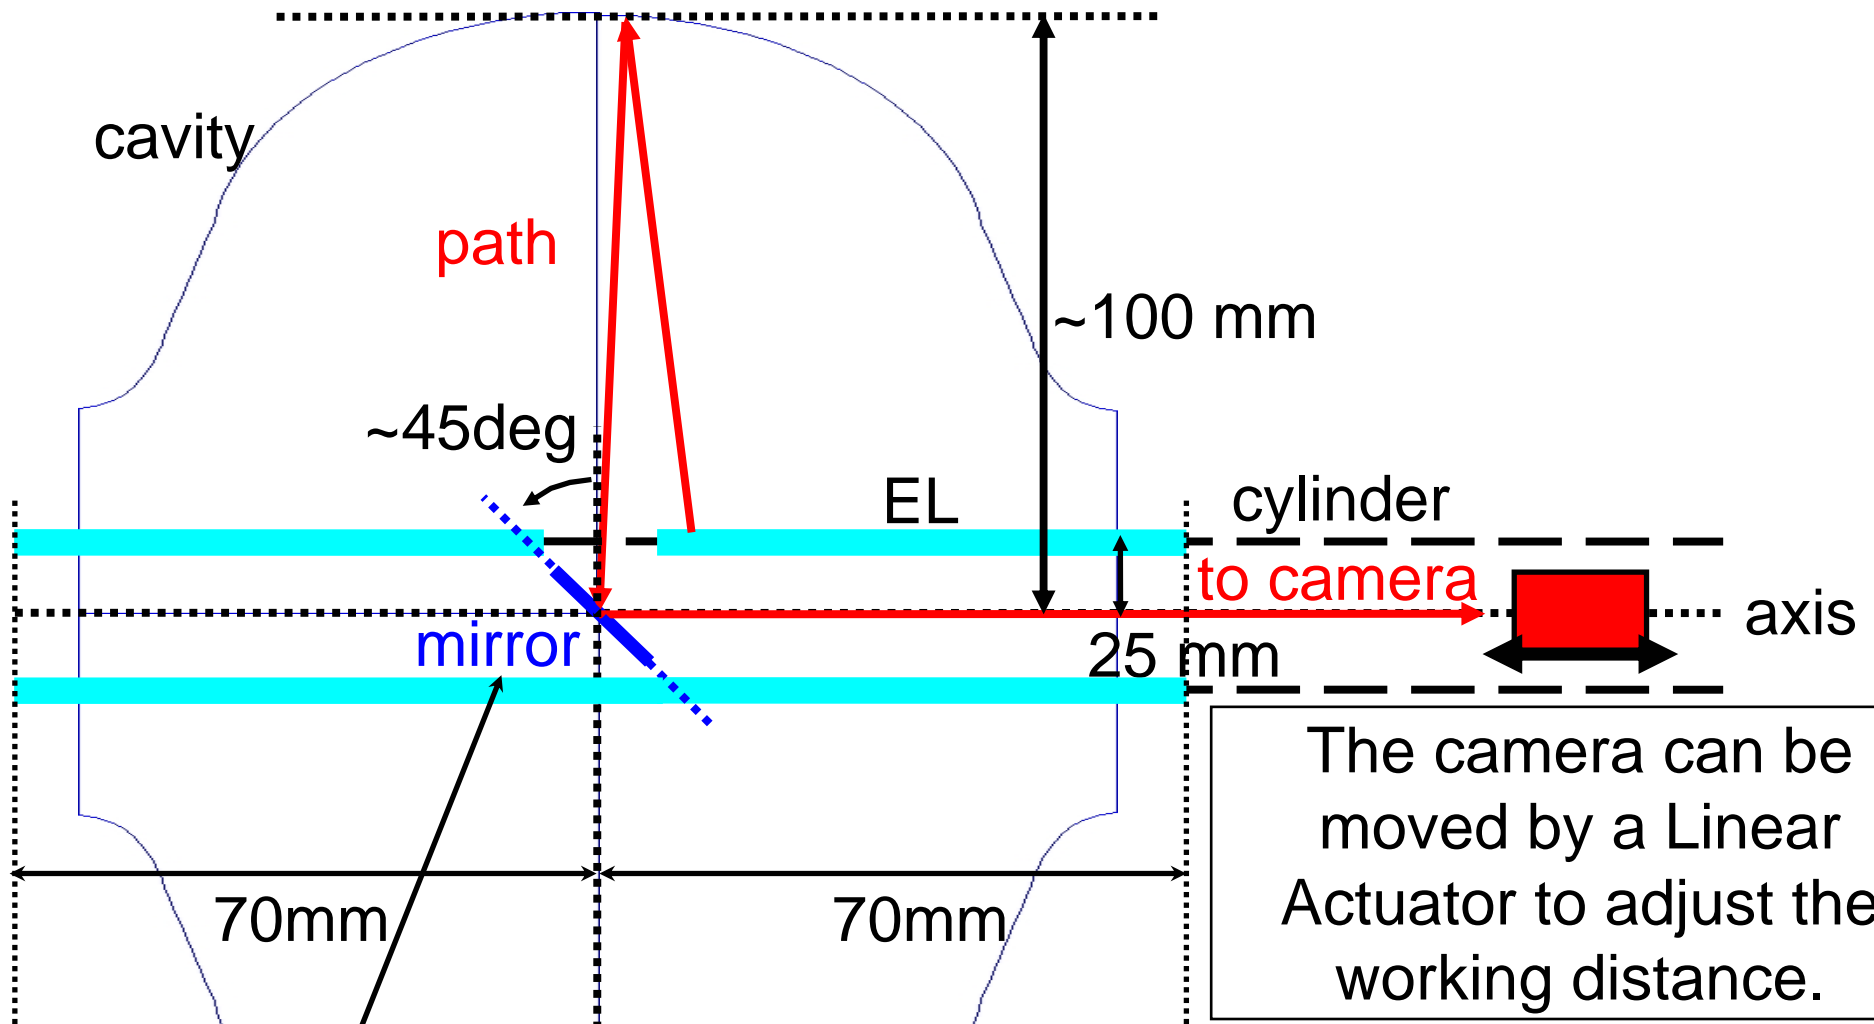
# Inside the Cylinder

Mirror can be tilted by a Pulse Motor.

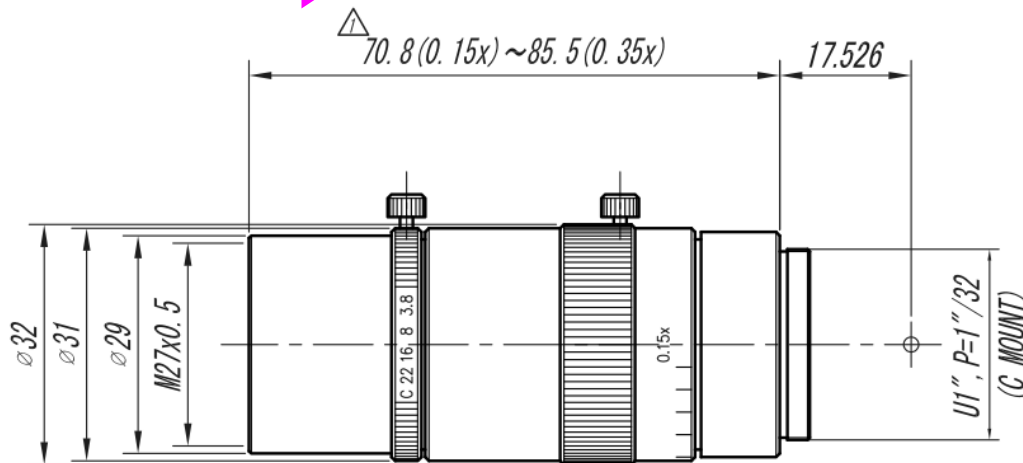
- 1.5M-pixel CMOS Color Camera  
1400px X1000 px: 5.0 $\mu$ m/px  
Toshiba teli CSF5M7C3L18NR
- Distortionless Lens(0.15x ~ 0.35x, f75mm)  
V.S. Technology Corp. VS-LD75
- 40mm Extension Tube (later)

Maximum resolution: ~0.70x, ~7 $\mu$ m/px (~15 $\mu$ m/px)  
Limited by the Working Distance~120mm

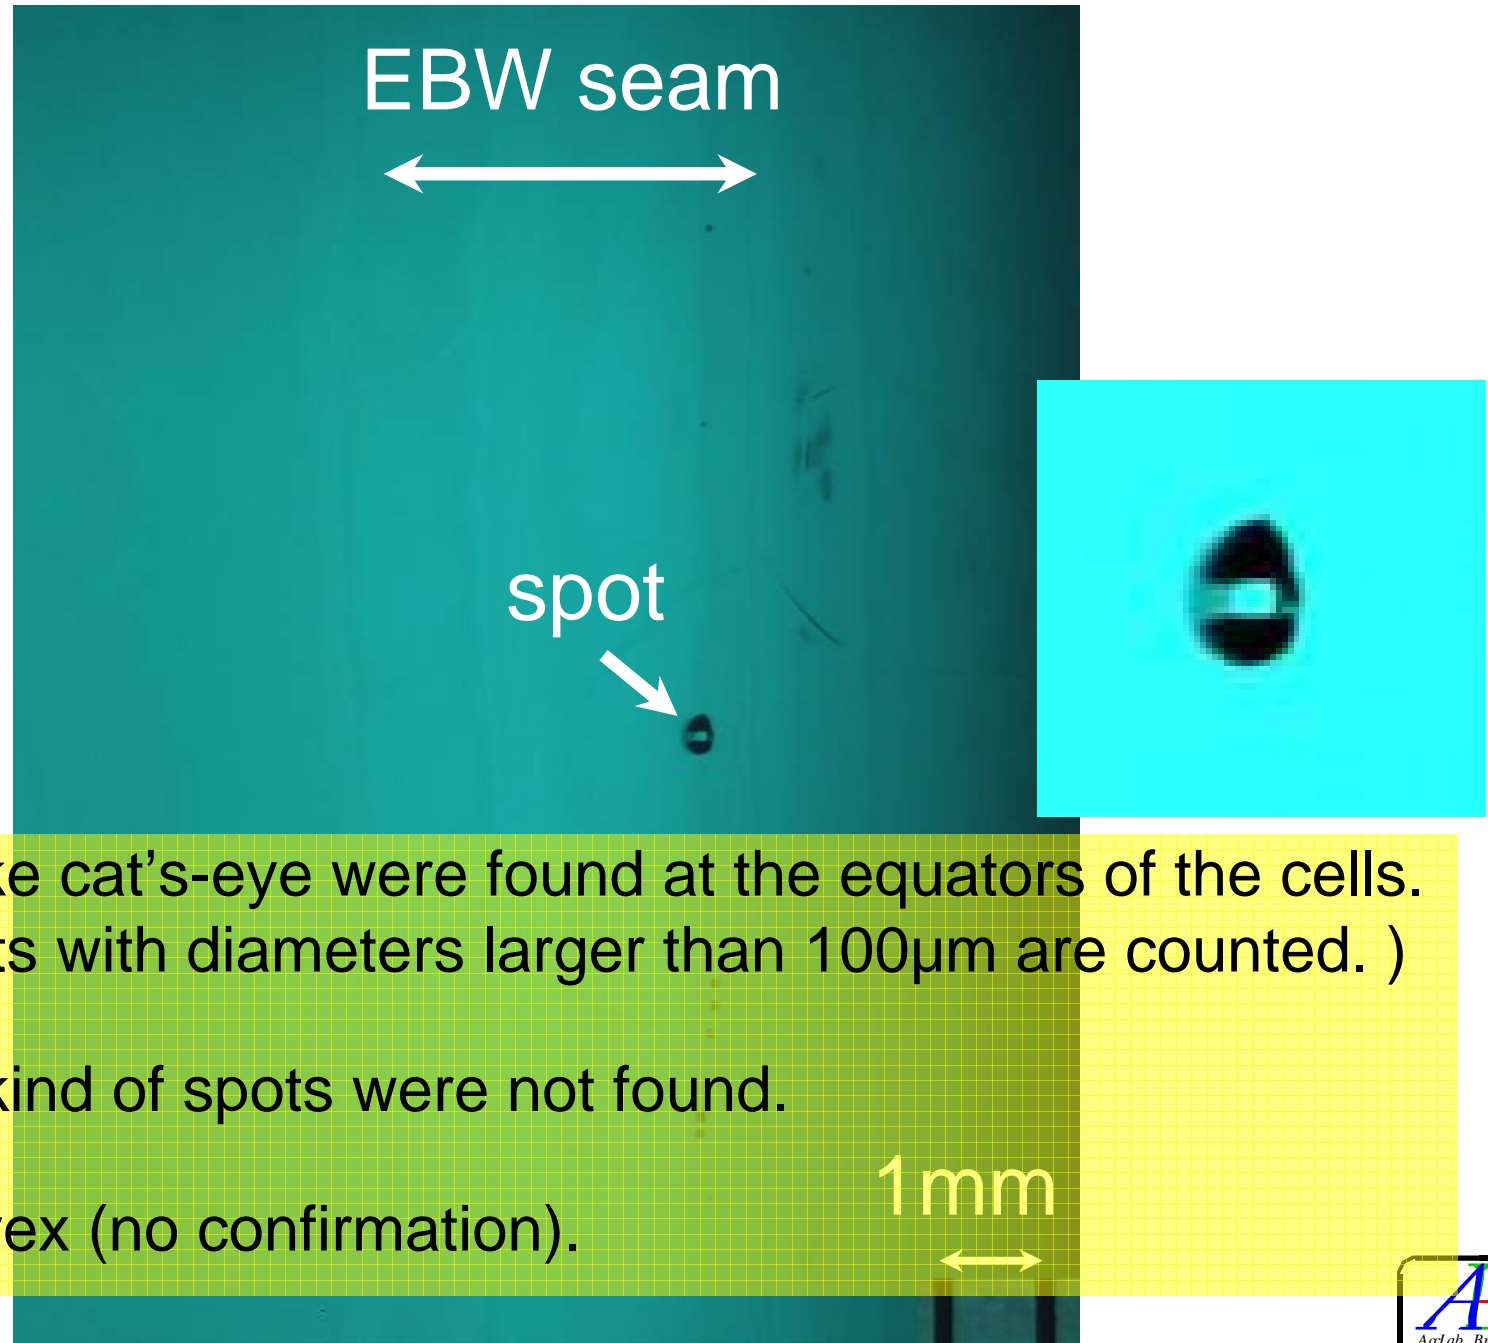
# Interior Surface of Zanon #84

- 28 spots like cat's-eye were found at the equators of the cells. (only the spots with diameters larger than 100 $\mu$ m are counted. )
- Any other kind of spots were not found.
- Likely convex (no confirmation).

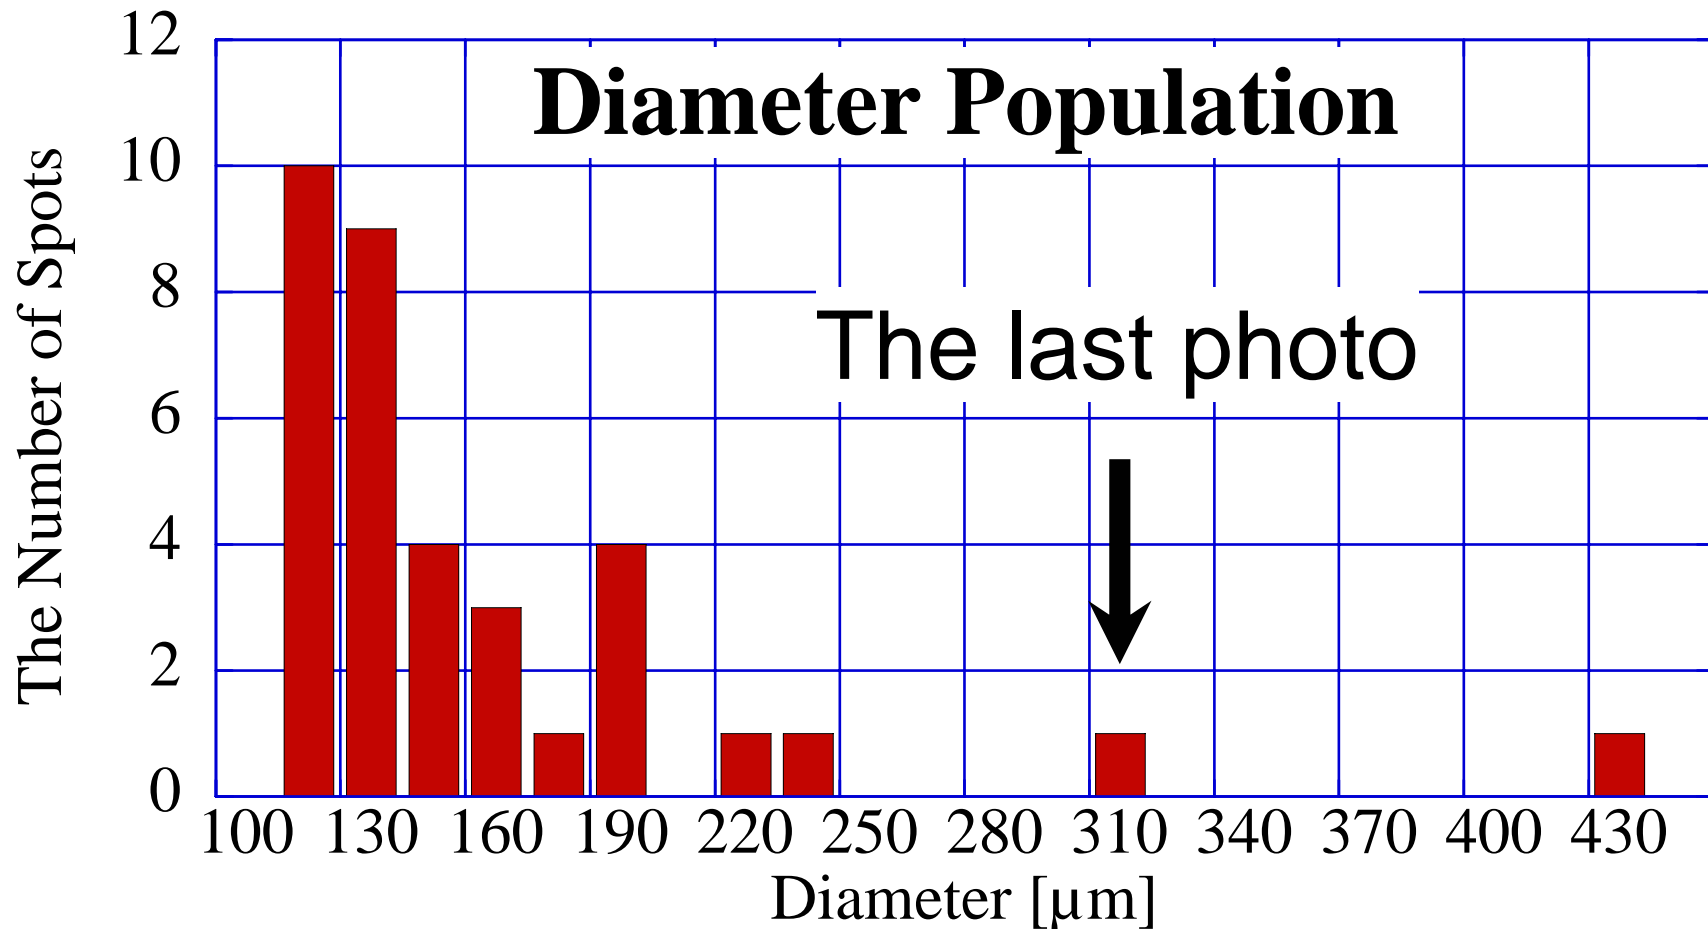
# Statistics of spots(>100 $\mu\text{m}$ ) in Z84

**REMARK:** All the spots were found at the input coupler side of the EBW seam.

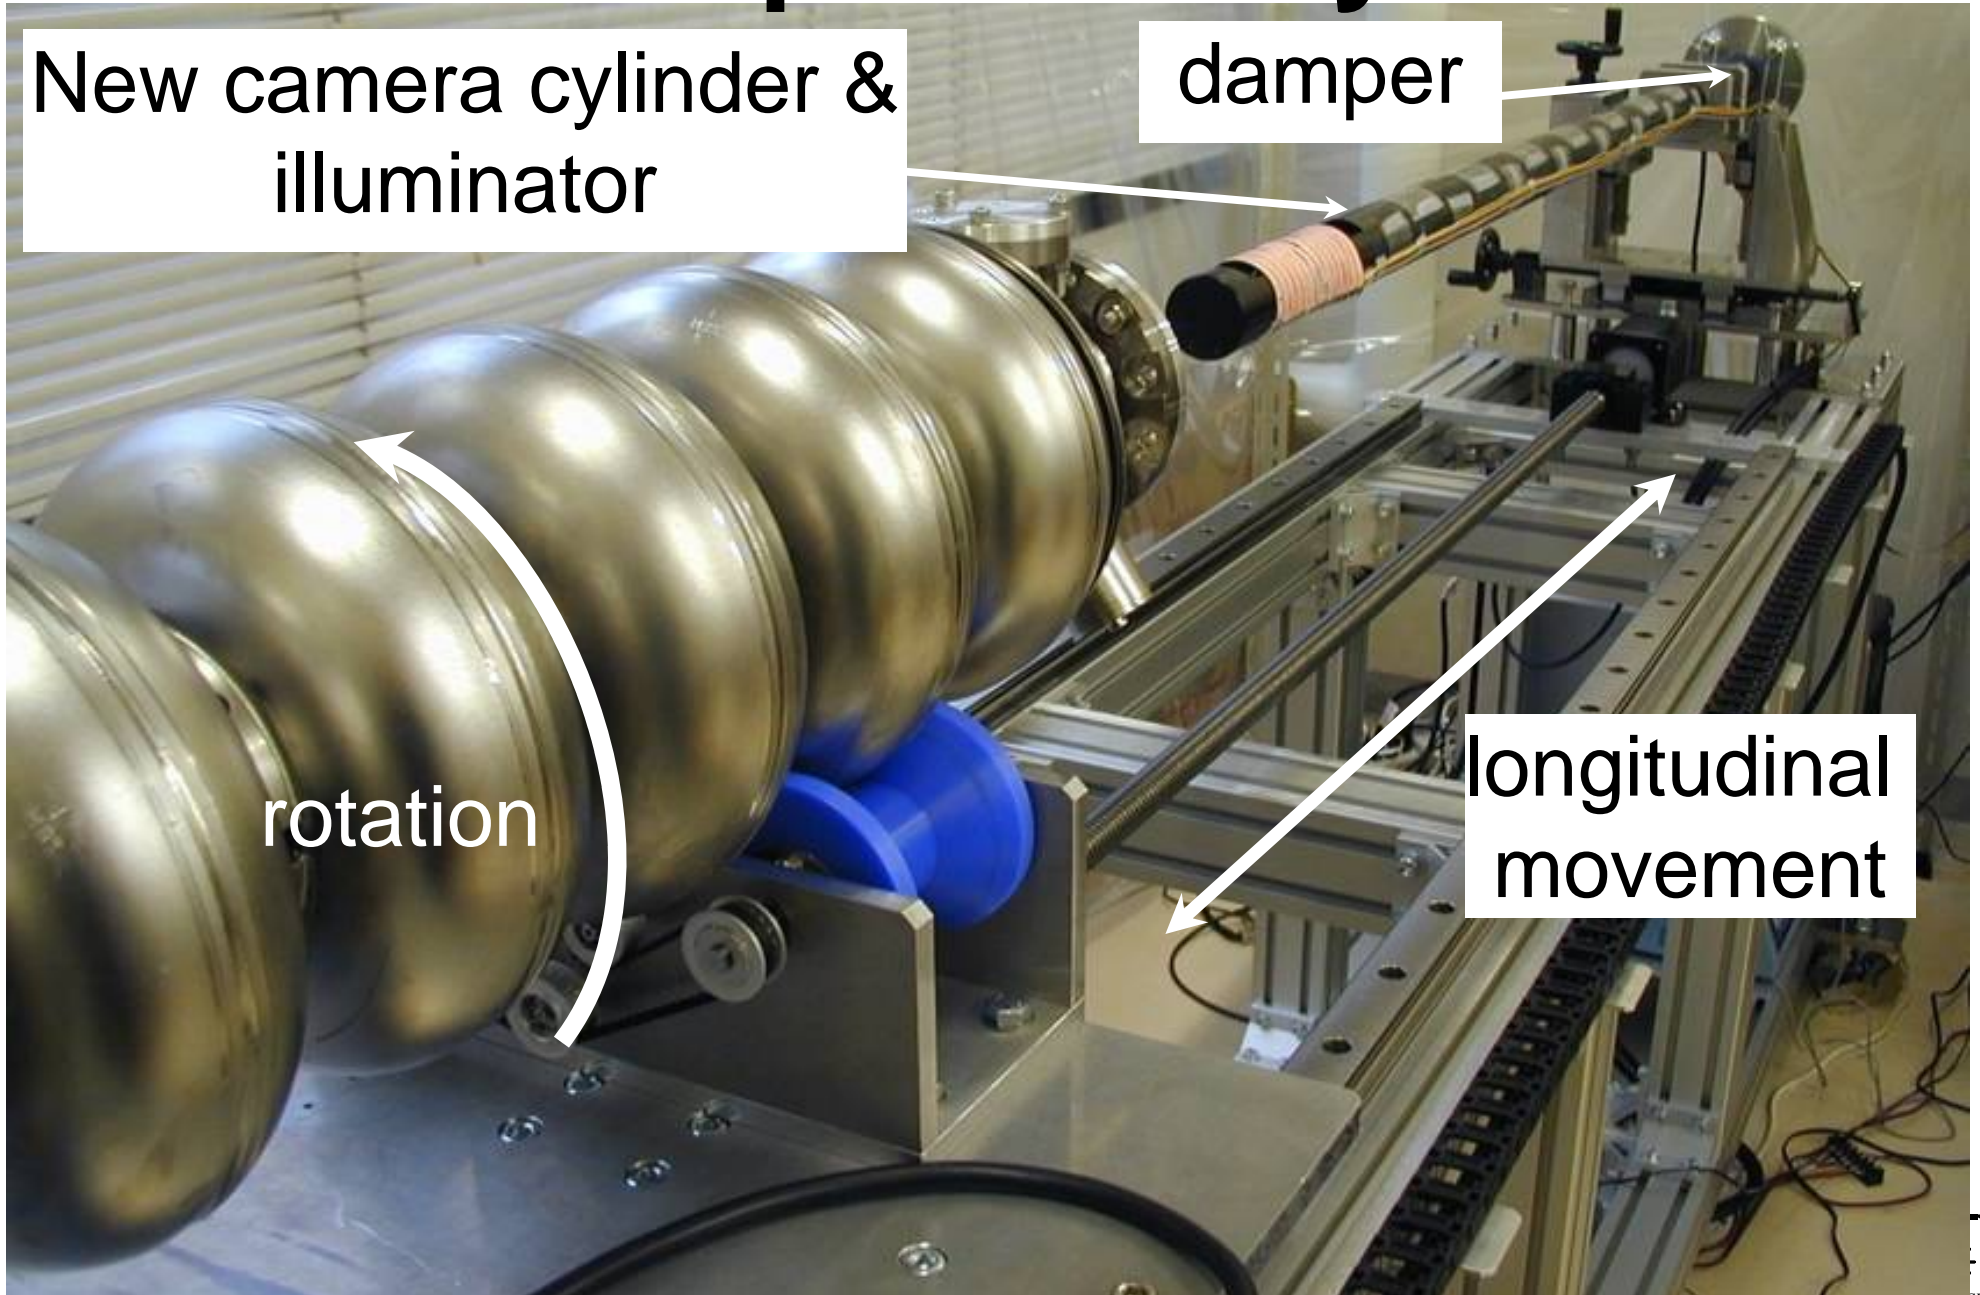
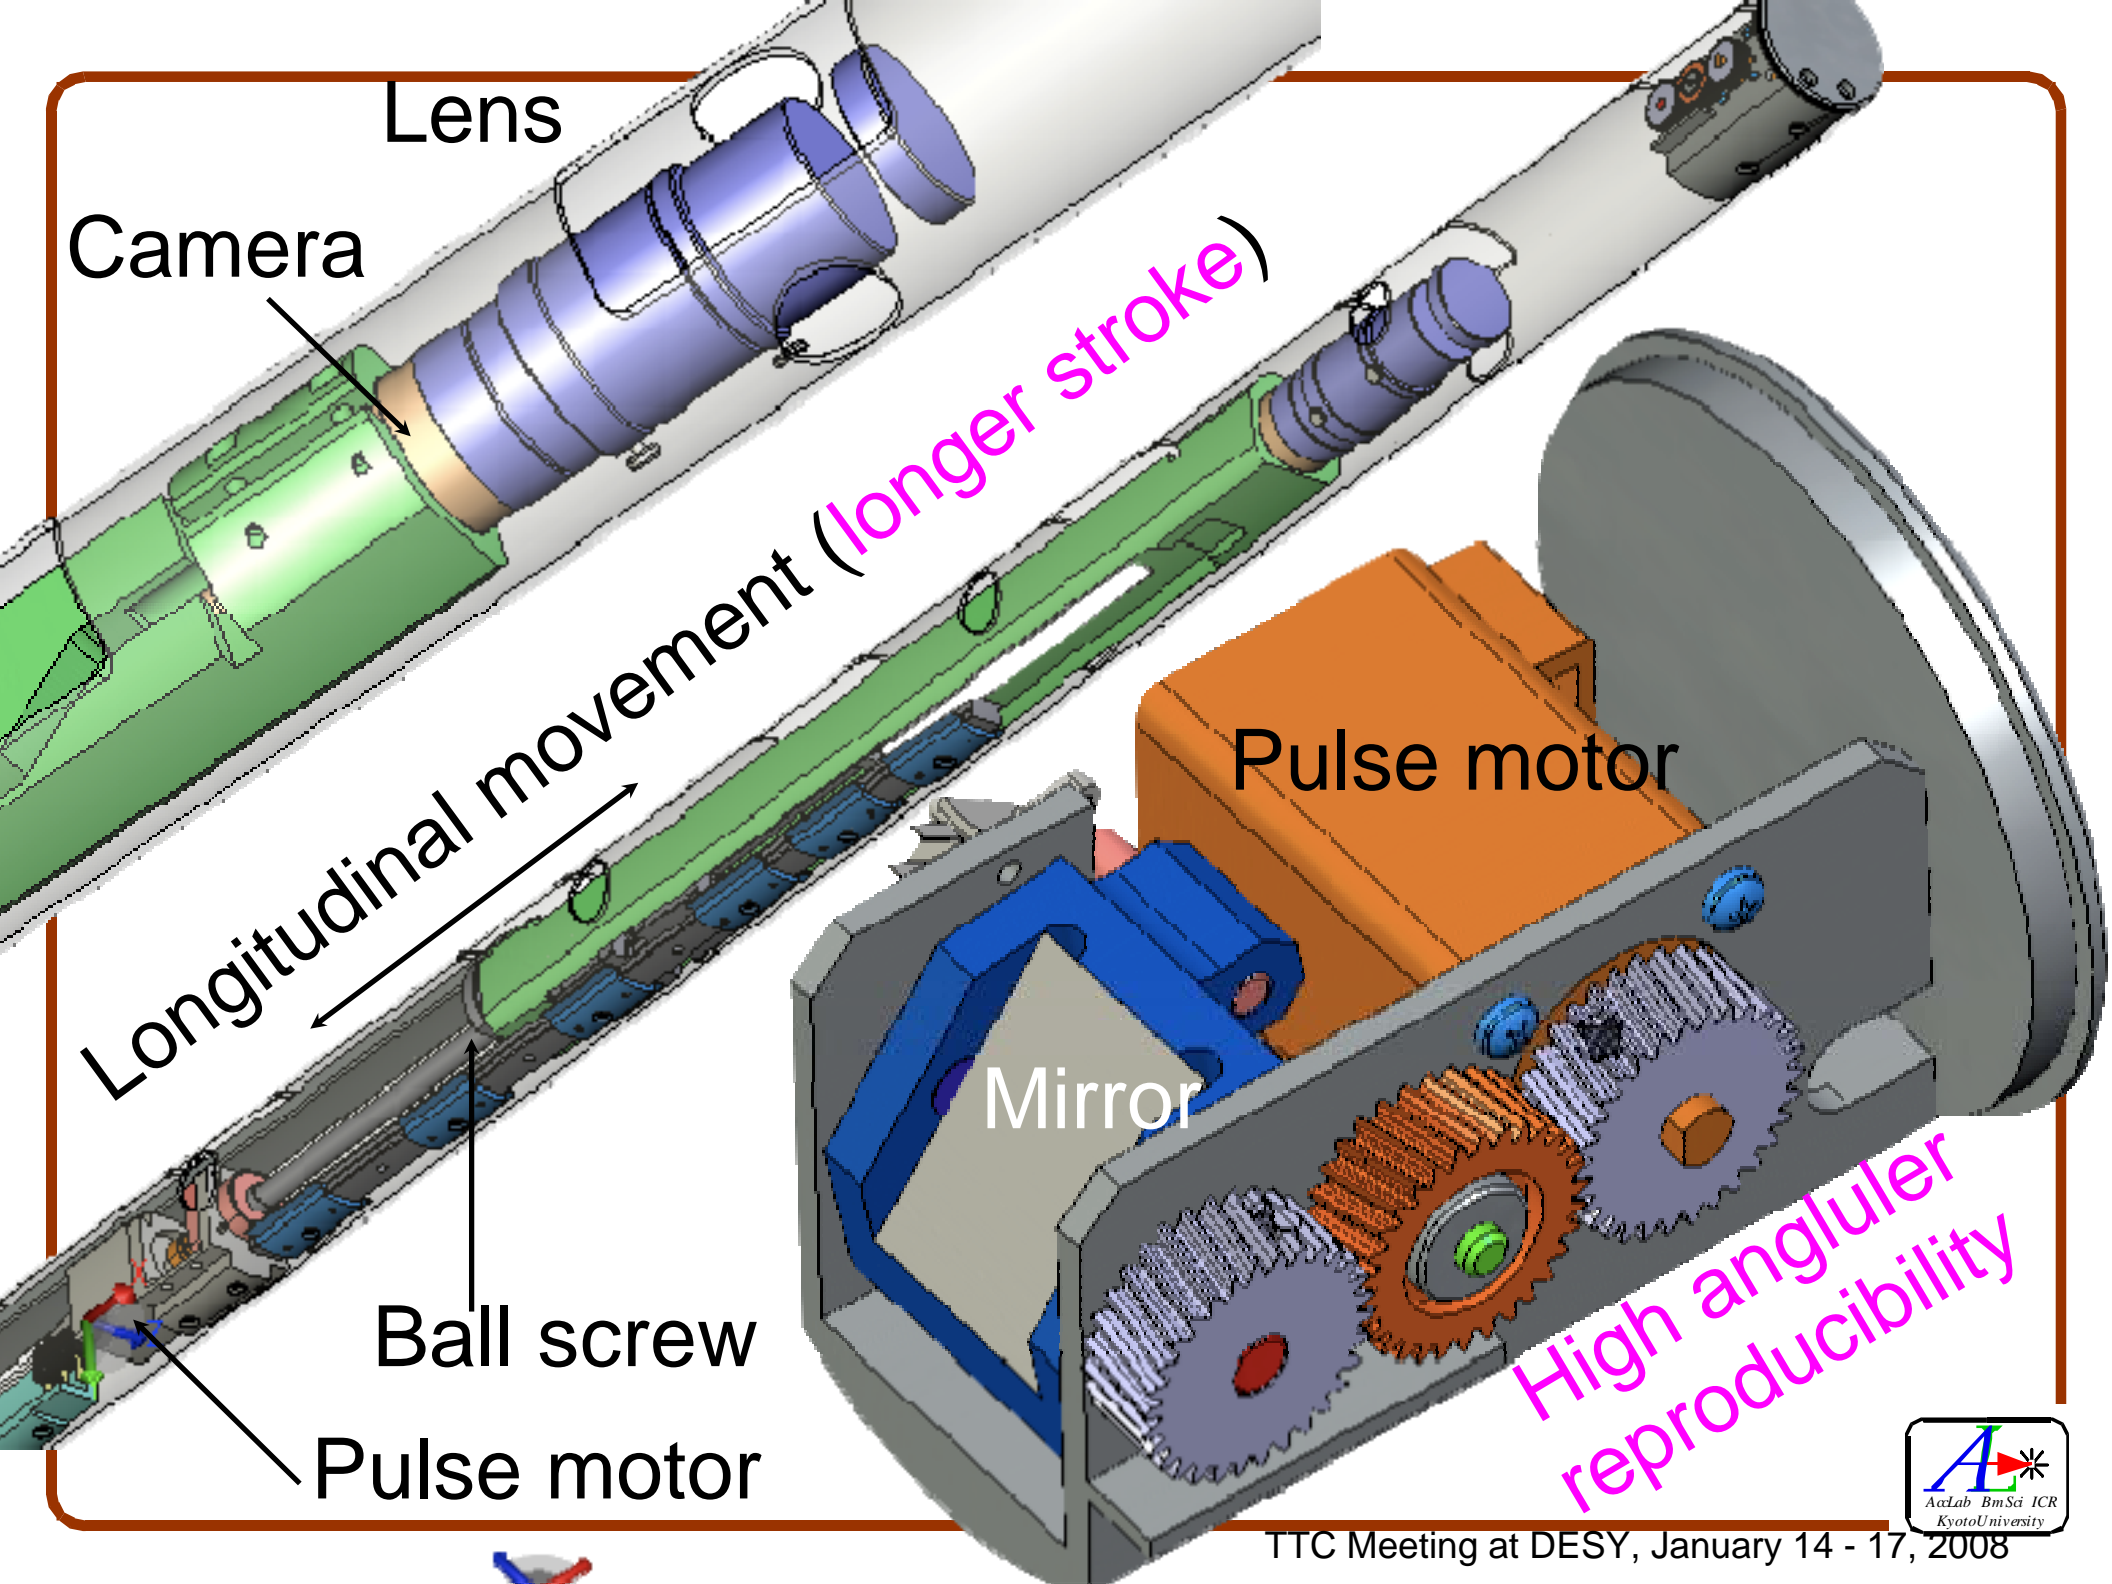
# New Inspection System

New camera cylinder & illuminator

Lens

Camera

Longitudinal movement (longer stroke)

Pulse motor

Mirror

Ball screw

High angular reproducibility

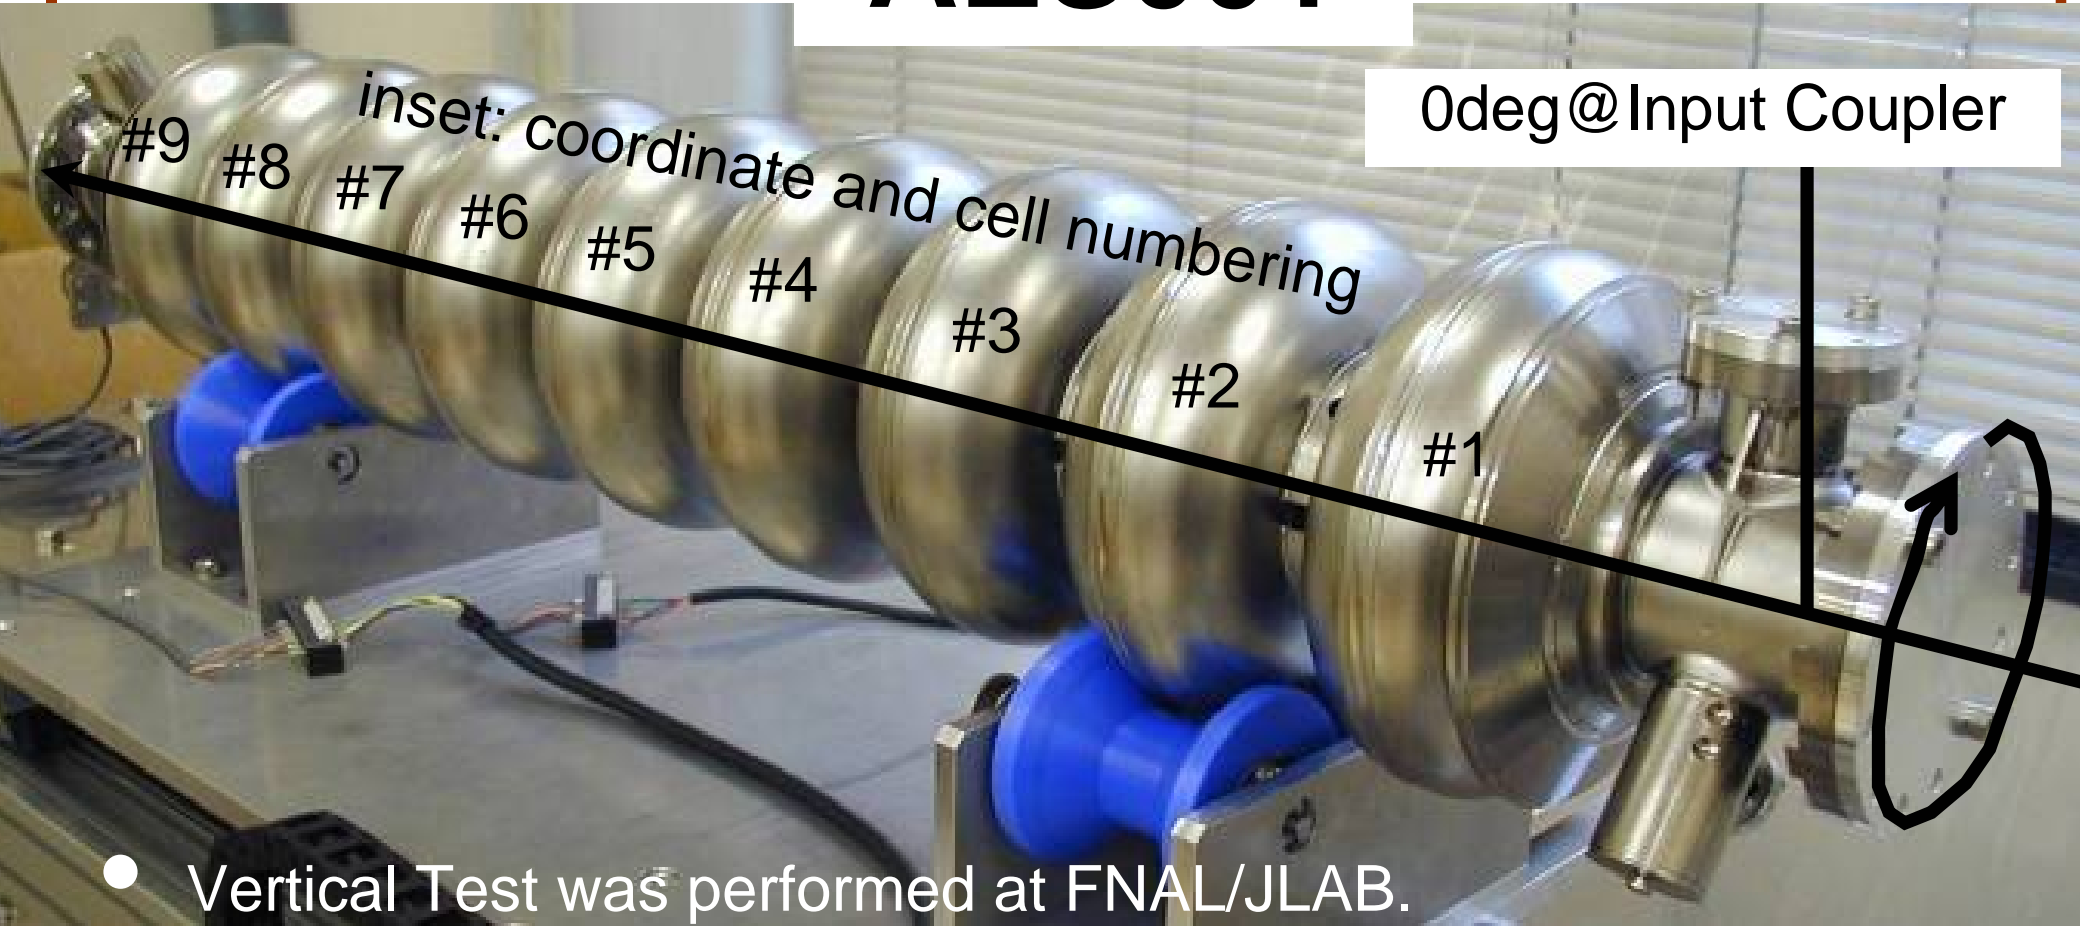
# AES001

- Vertical Test was performed at FNAL/JLAB.
- Quenched at  $E_{acc} \sim 15 \text{ MV/m}$  without field emission (no Xray).
- Passband mode measurements shows that #3 and #7 cell are suspicious.
- In CERNOX measurements two hot spots were found at the equator region of #3 cell.

**AES001 has hard quench at 15MV/m, where its location was identified by Cernox at FNAL.**

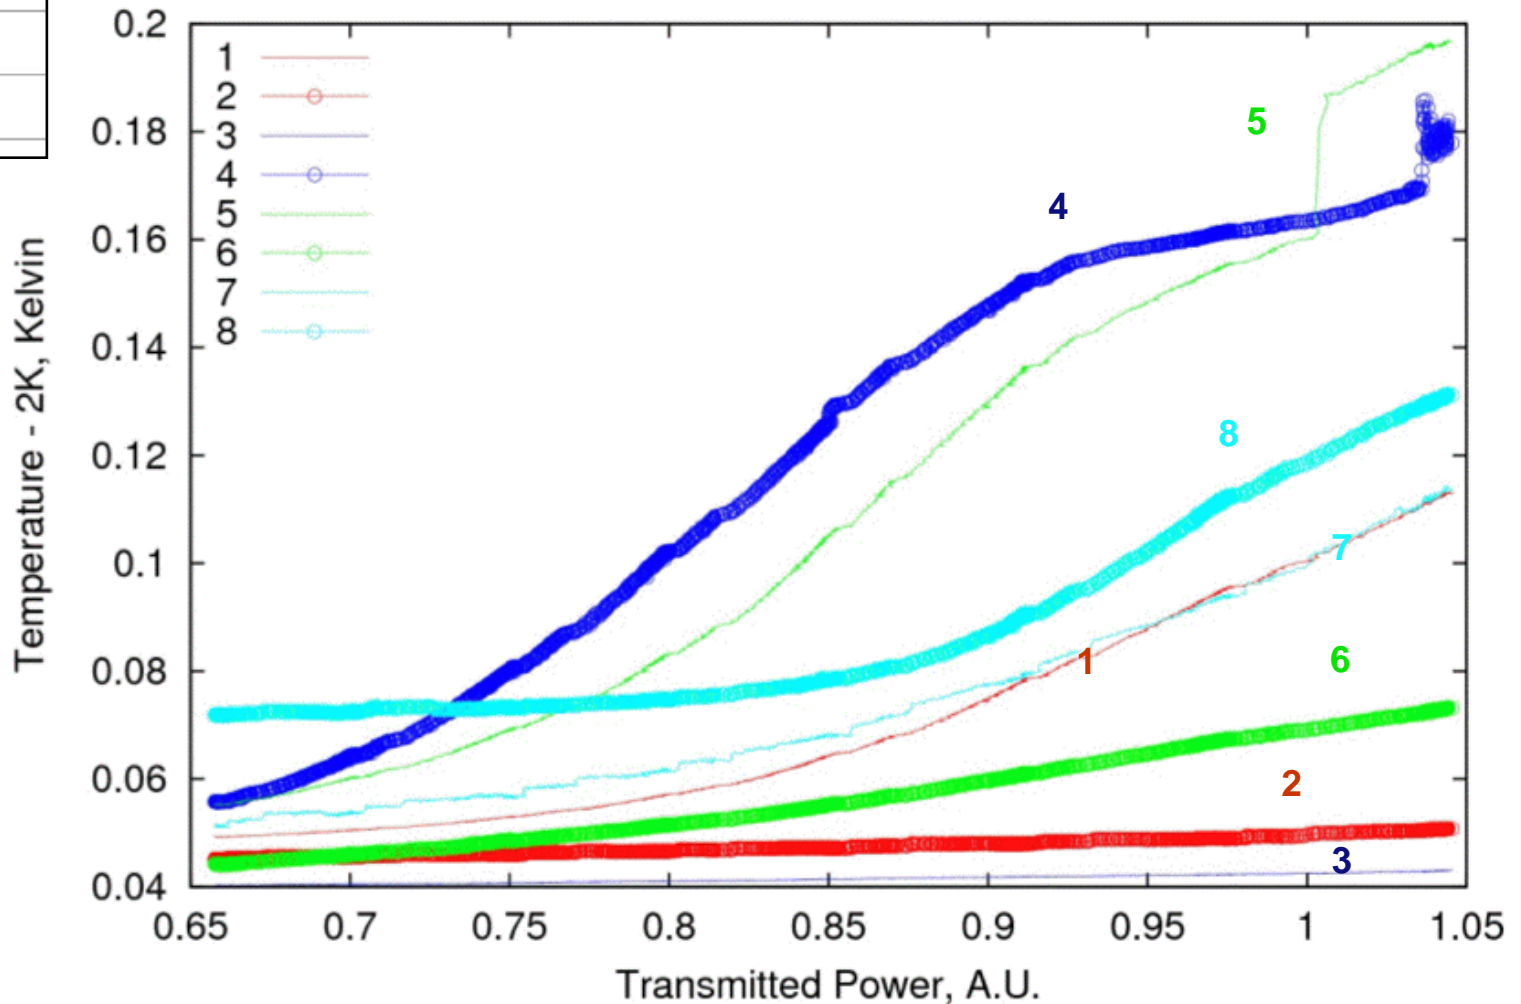
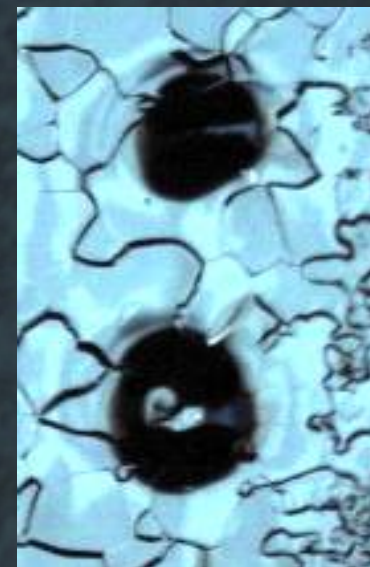
AES001 #3 cell 169°

Larger grains

Fine grains

EBW area: Larger Grain

Twins

spot(a) @ 168°

spot(b) @ 169°

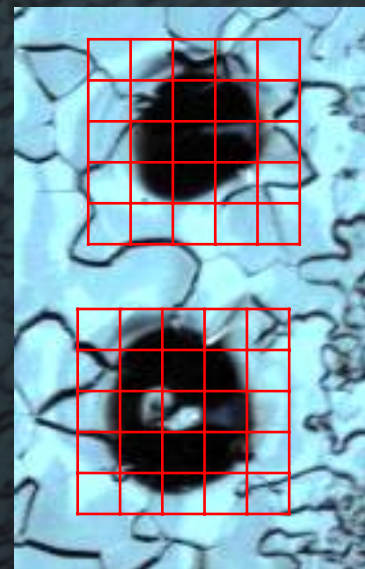
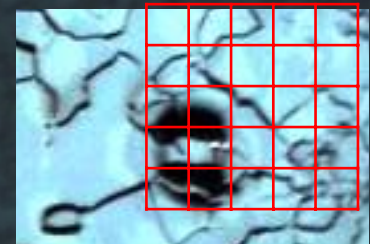
AES001 #3 cell 181°

EBW affected area

Larger grains      Transition?

Fine grains

↑  
spot

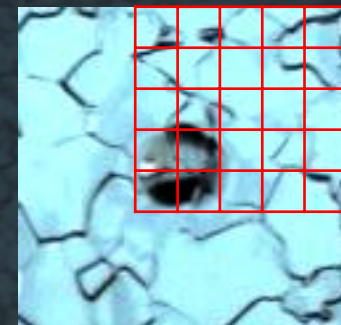
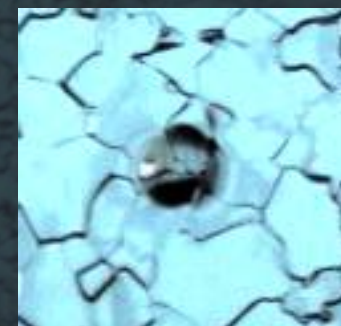
AES001 #7 cell 325°

EBW affected area

Largest grains

Larger grains  
Transition?

Fine grains

spot

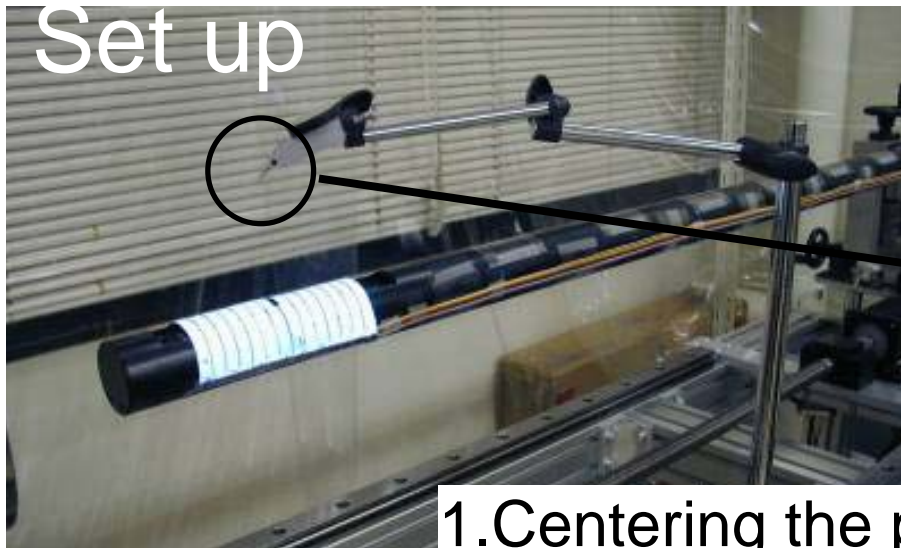
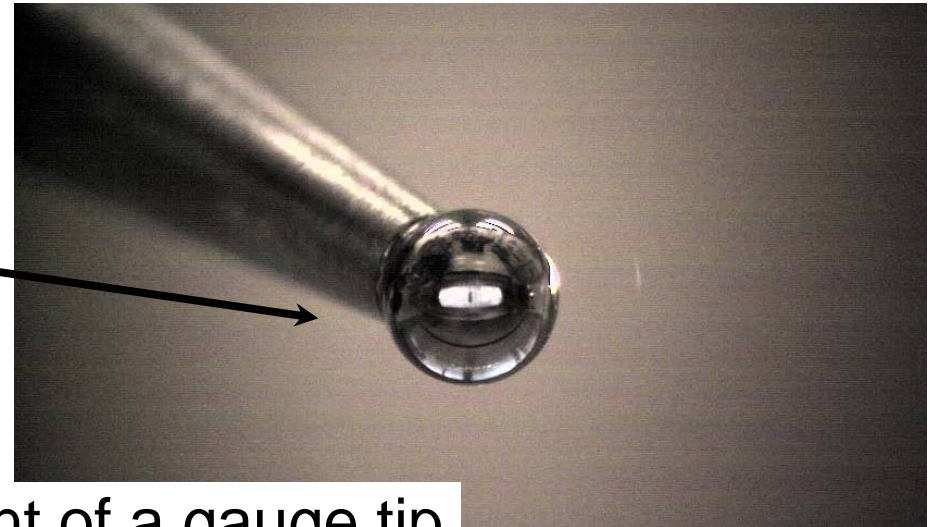
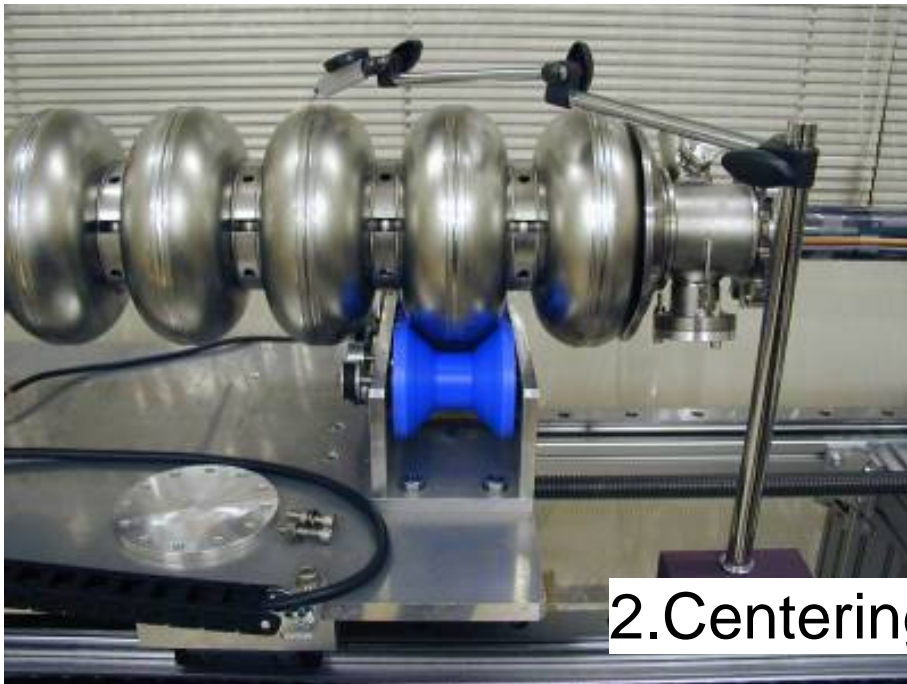
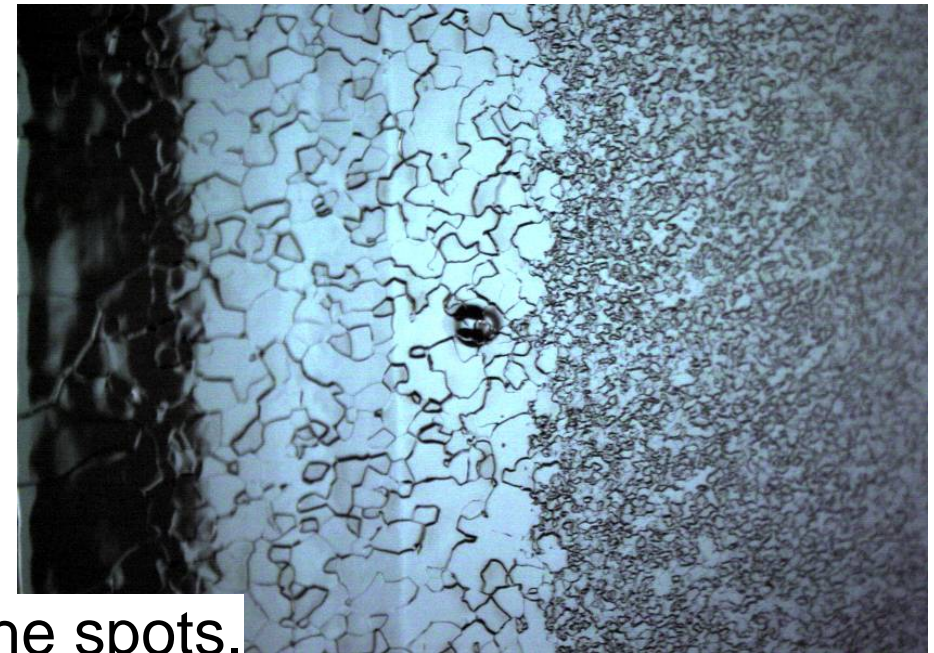
# Determination of Spot Positions

1.Centering the point of a gauge tip.

2.Centering the spots.

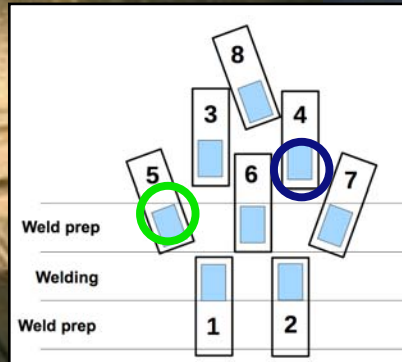
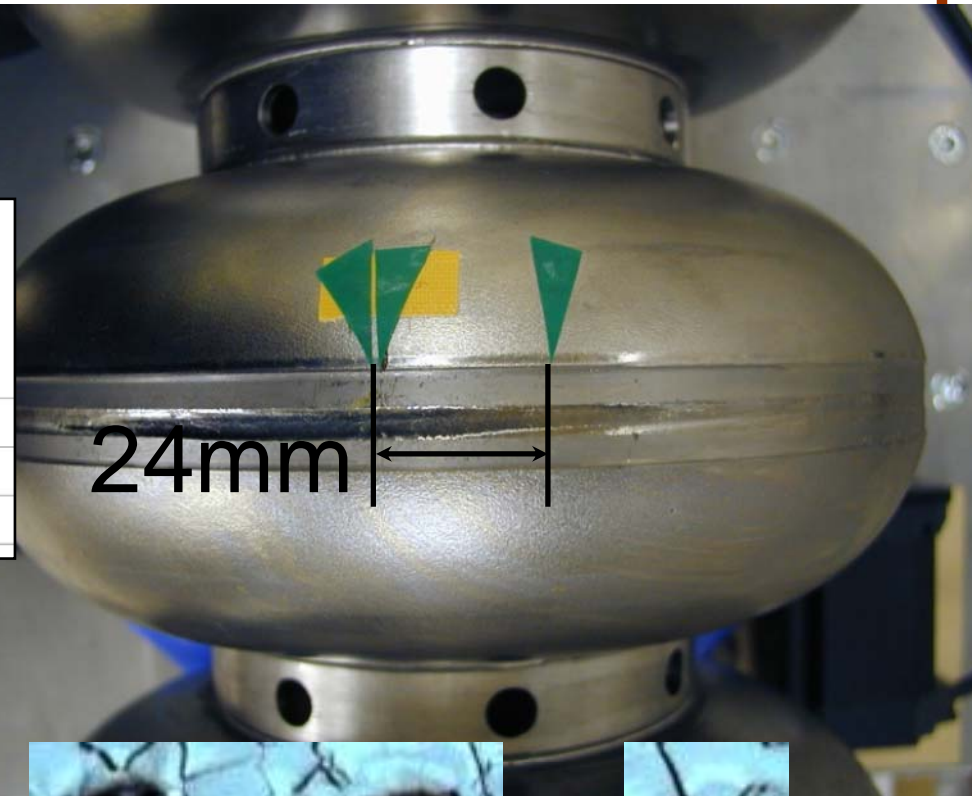
# Correlation with Thermometry

Two thermometers shows the temperature rise.

The width of the themometers are about 5mm.

Two hot spots @ FNAL/JLAB

Three spots found @ Kyoto

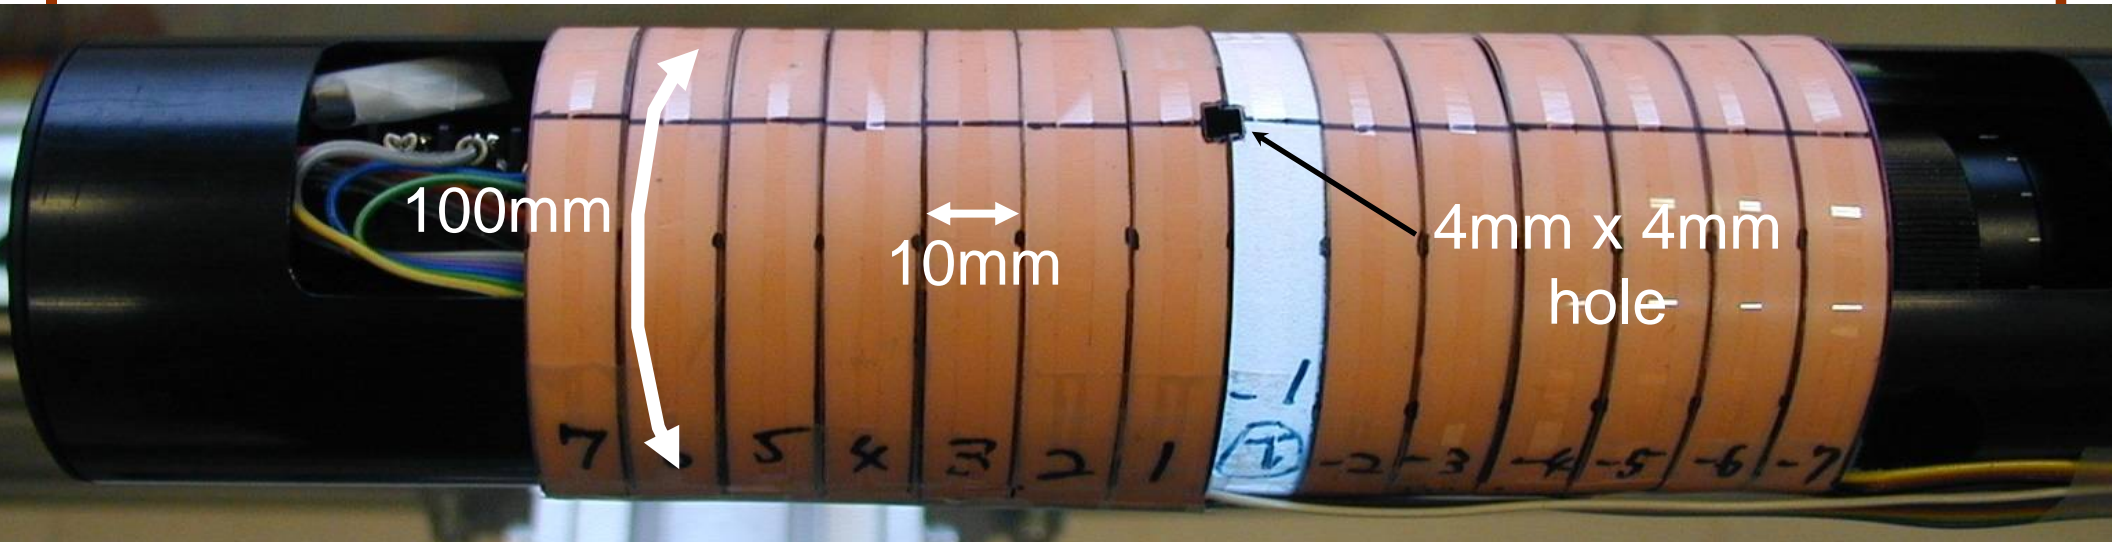
# Stripe Illumination(SI)

- Fourteen Electro-Luminescence(EL) strip sheets are 10mm in axial direction and cover 100mm in azimuthal direction.
- These fourteen strips can be turned ON/OFF one by one.
- Assuming that cavity's interior surface is a complete mirror, we can measure wall gradients of the cavity's interior surface with these ELs.
