**ACCELERATOR LABORATORY**  
**ADVANCED RESEARCH CENTER FOR BEAM SCIENCE**  
**INSTITUTE FOR CHEMICAL RESEARCH**  
**KYOTO UNIVERSITY**

# Development of High Resolution Camera and Observations in TESLA Cavities

Y. Iwashita, Y. Tajima and H. Hayano

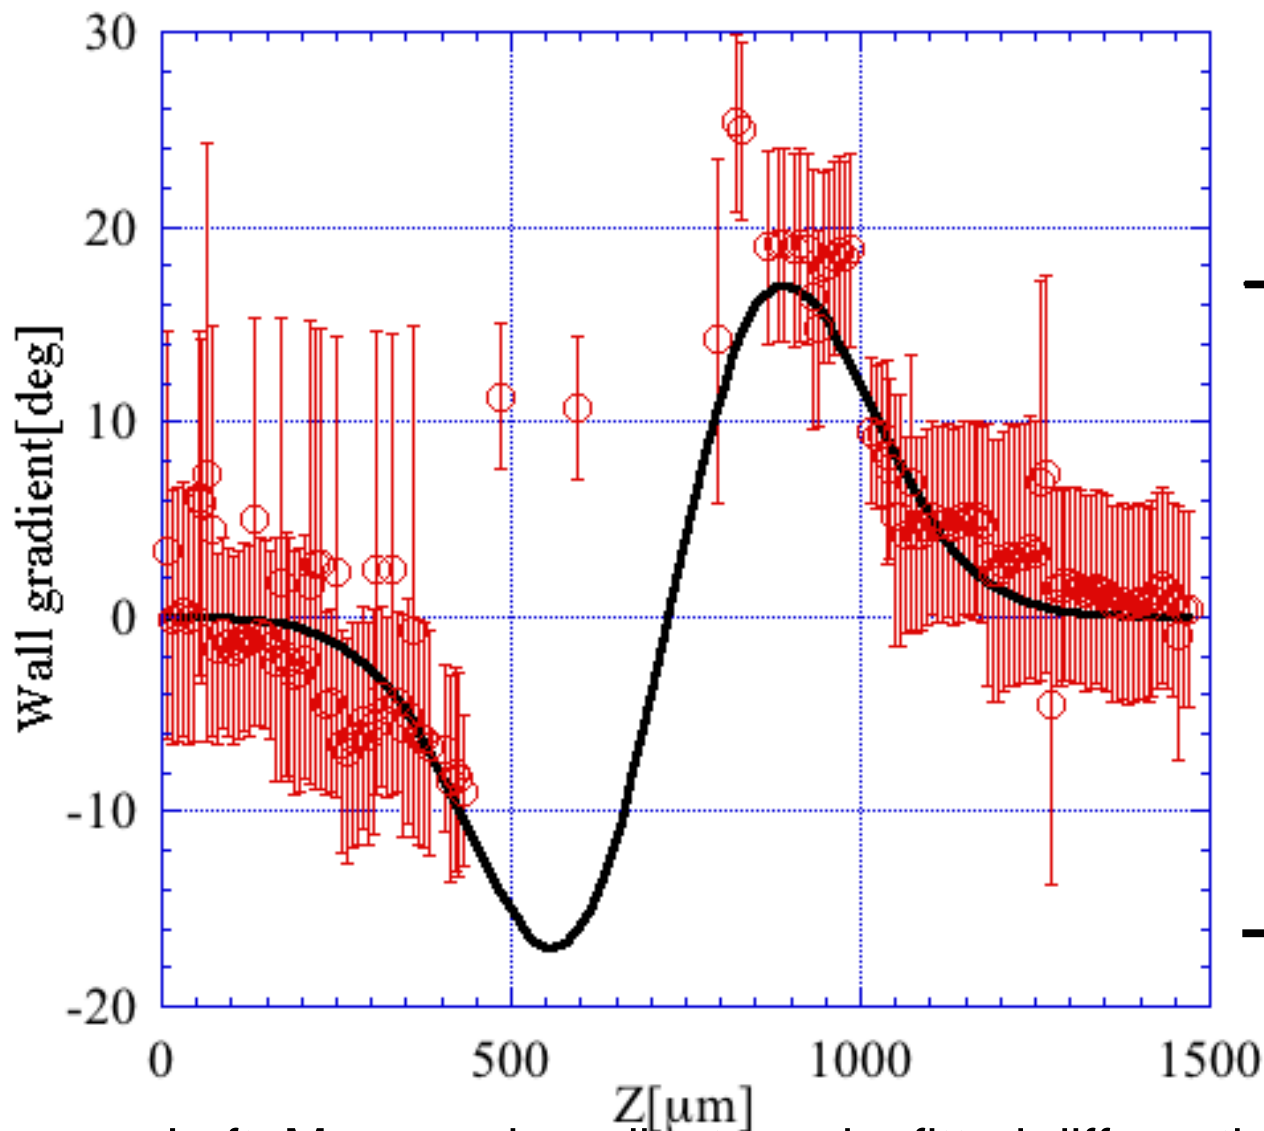
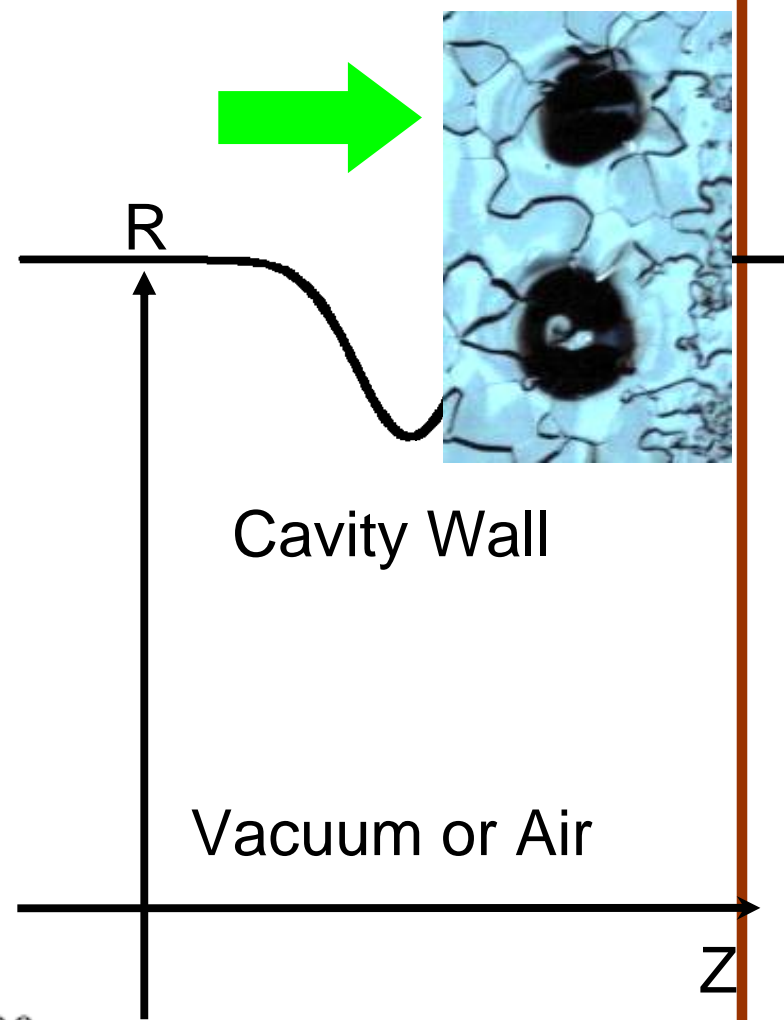
# Wall Gradient of spot at #3 cell 168°

Left: Measured gradients and a fitted differential gaussian.

Right: Schematic drawing of the integral of the fitted curve in the left.

This data shows that the spot is a convex(ball).

From the fitted differential gaussian, the height is 84 $\mu\text{m}$ .

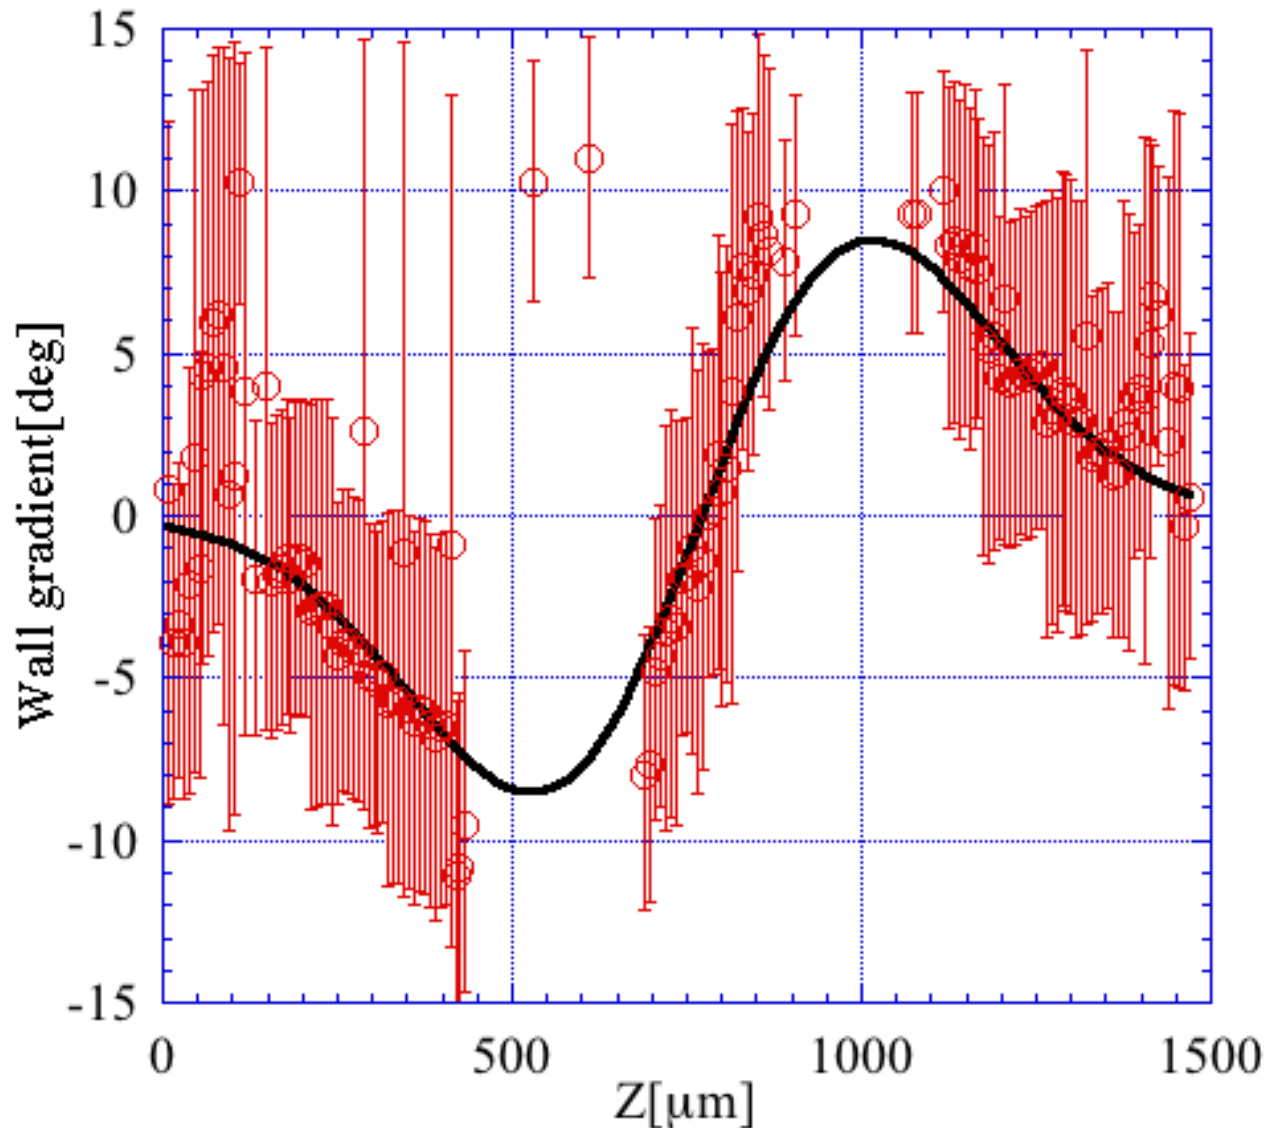
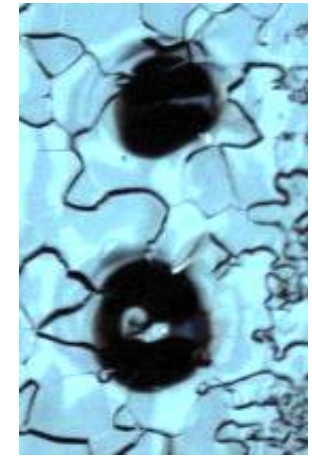
# Wall Gradient of spot at #3 cell 169°

This data shows that the spot is a convex(ball).  
From the fitted differential gaussian, the height is  $60\mu\text{m}$ .

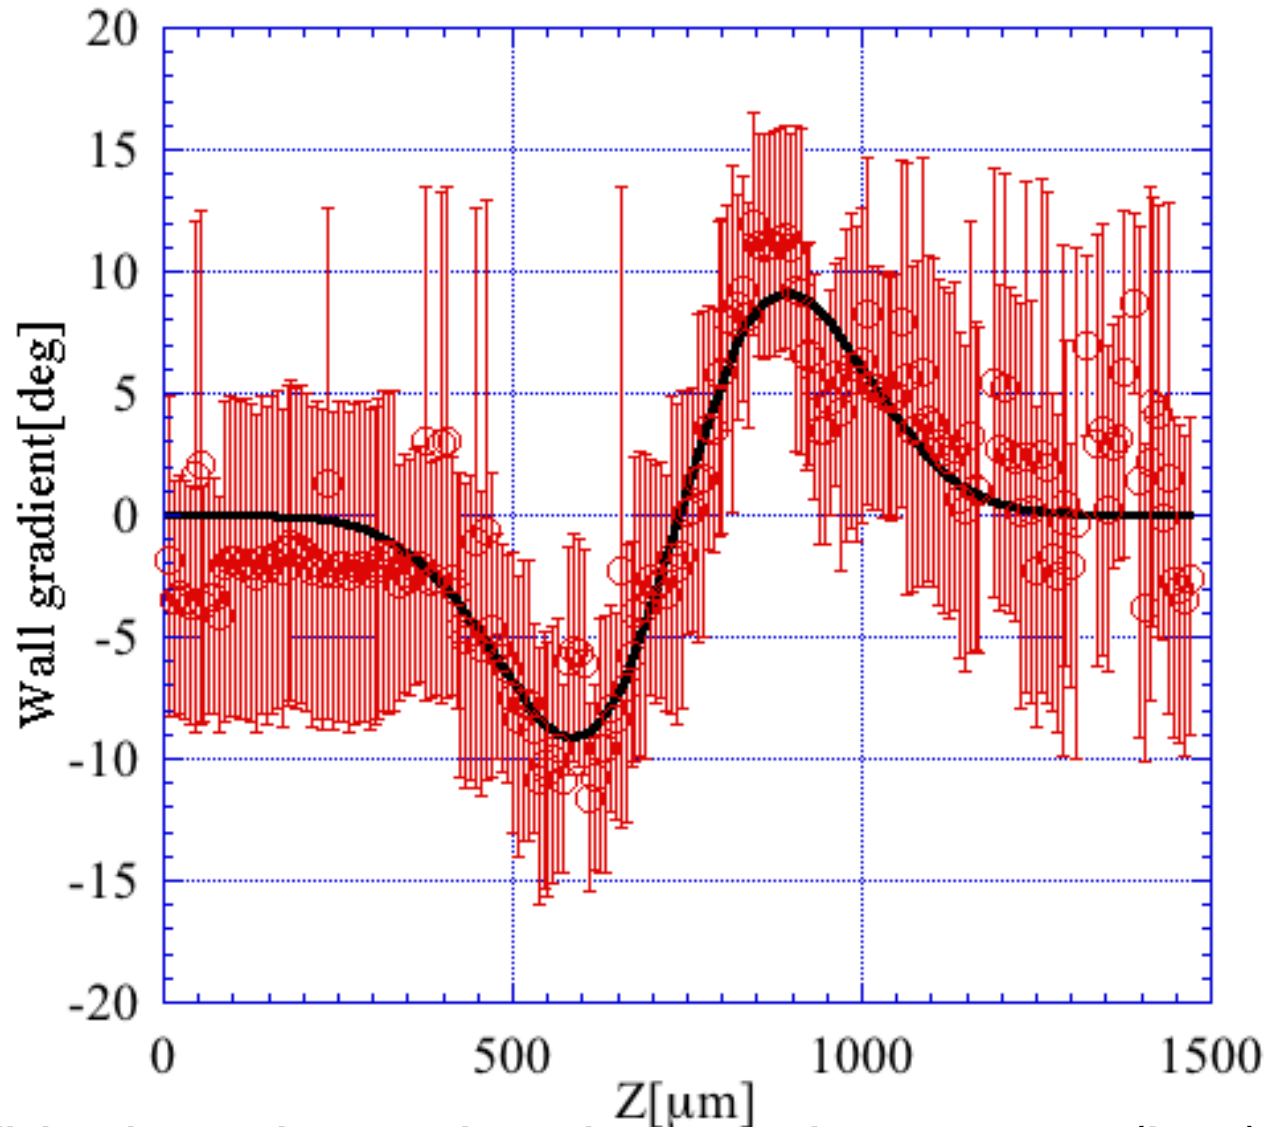
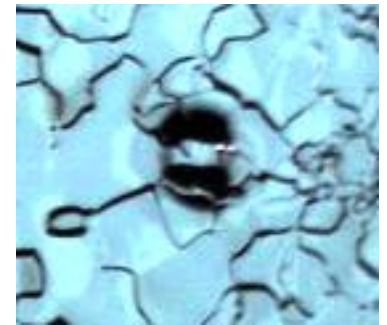
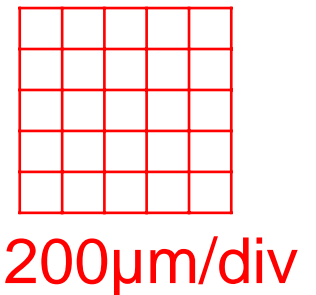
# Wall Gradient of spot at #3 cell 181°

- This data shows that the spot is a convex(ball).
- Because of the continuity of the measured gradient, we can integrate the gradient to estimate the height of the spot.

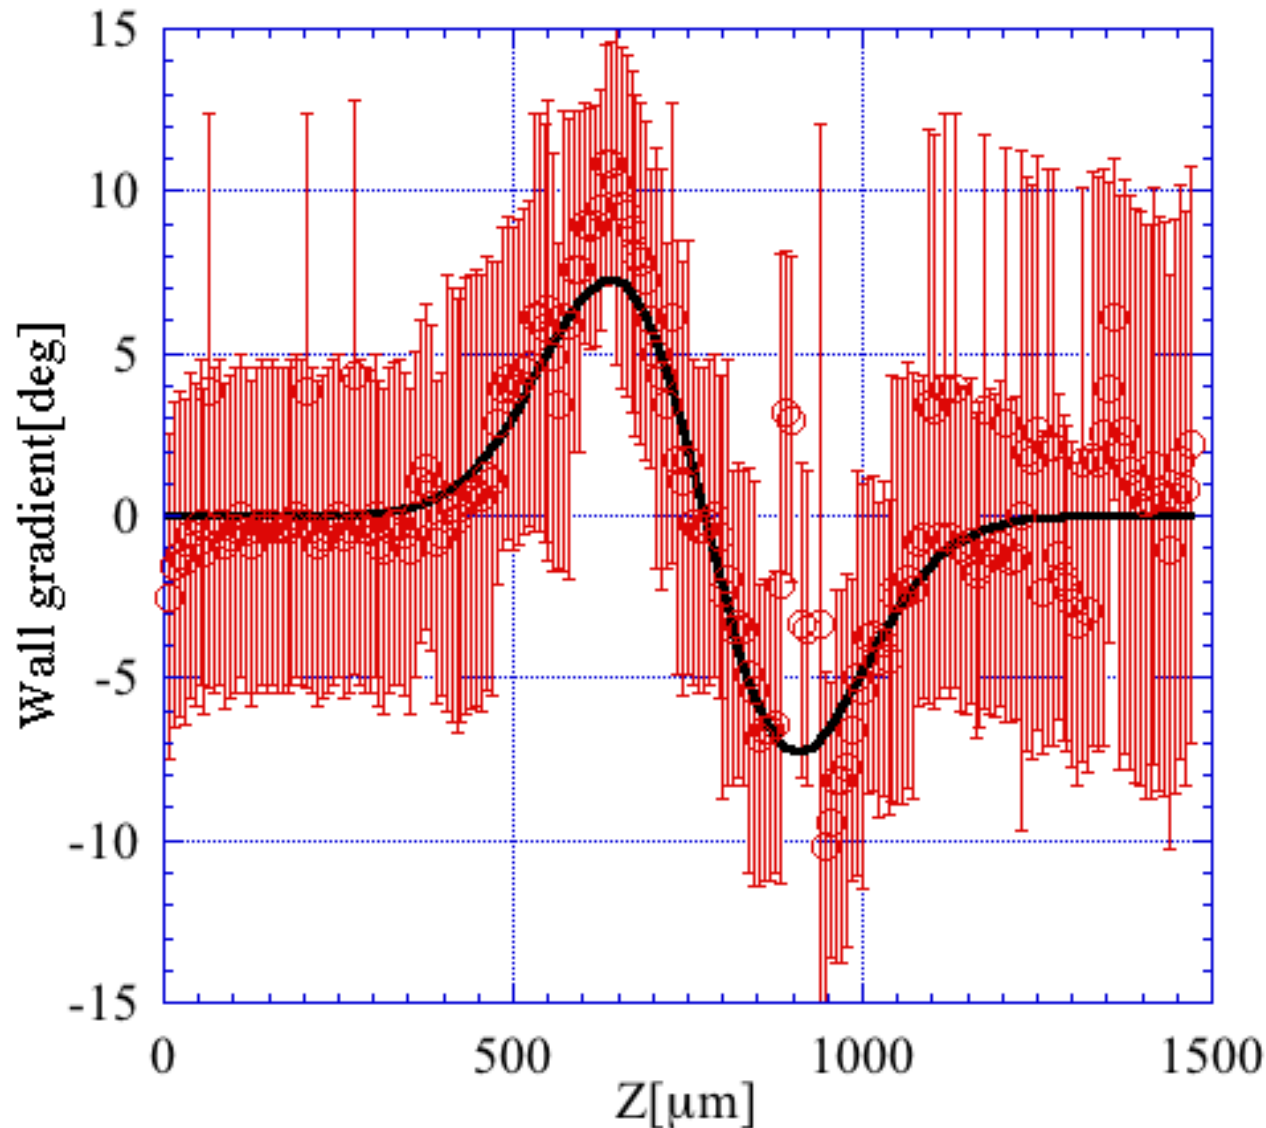
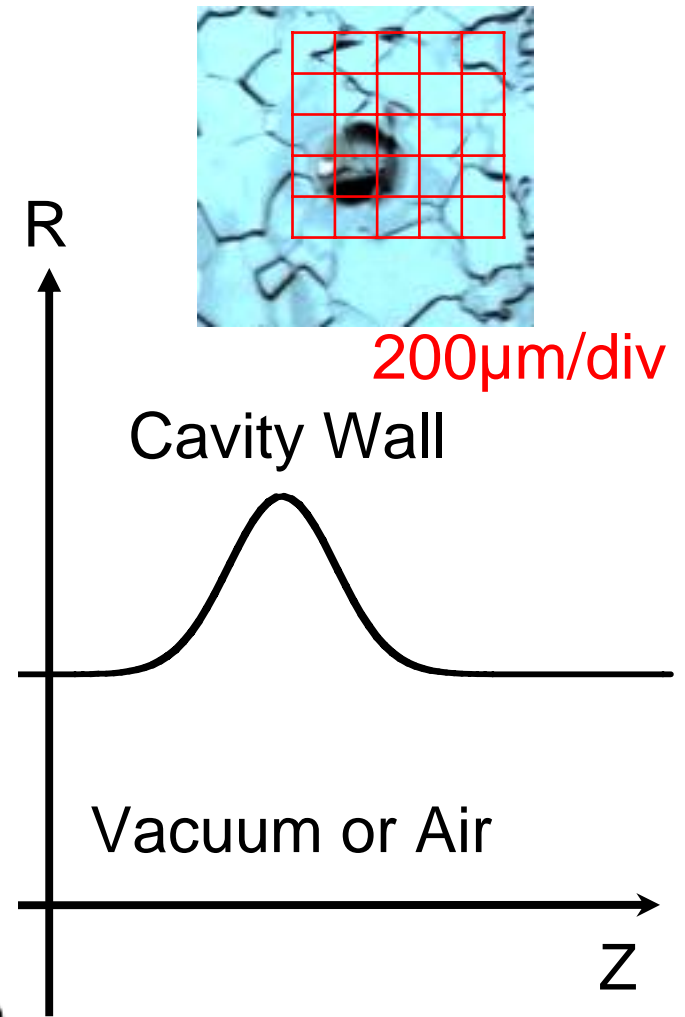
# Wall Gradient of spot at #7 cell 325°

Left: Measured gradients and a fitted differential gaussian.

Right: Schematic drawing of the integral of the fitted curve in the left.

This data shows that the spot is a concave(pit).

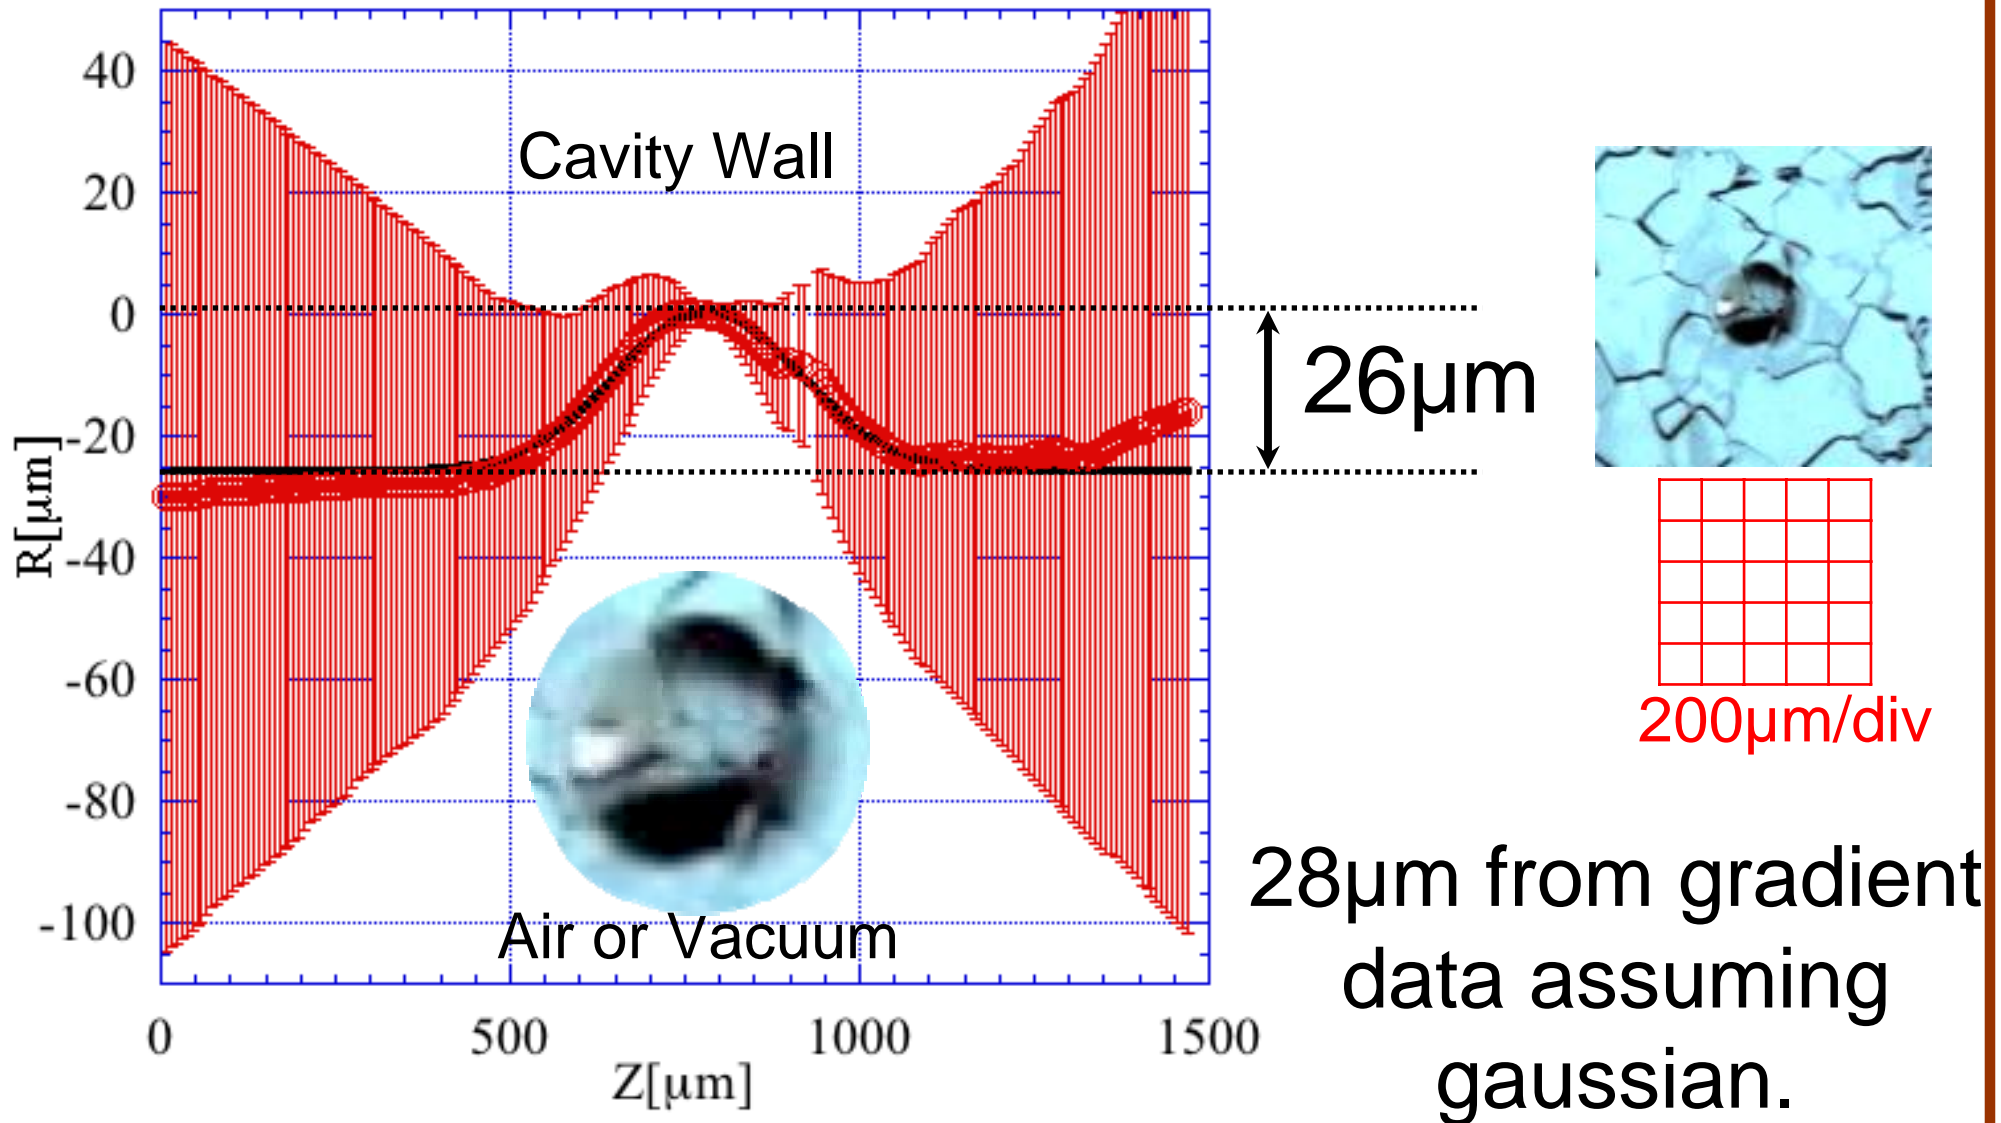
# Height of spot at #7 cell 325deg

Black curve is a fitted gaussian.

$28\mu\text{m}$  from gradient data assuming gaussian.

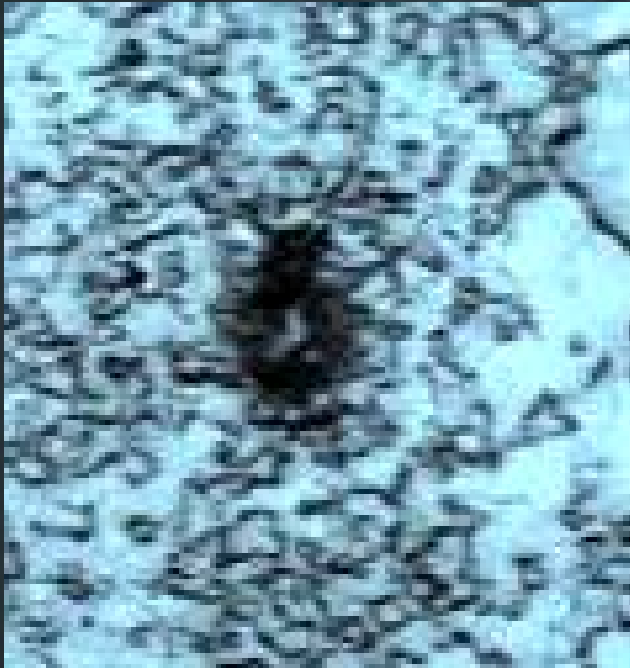
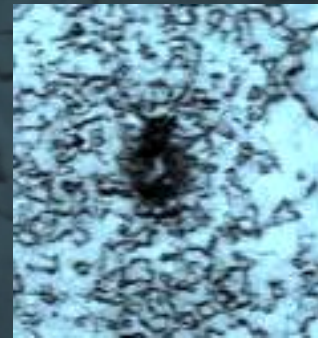
AES001 #1 cell 252°

EBW seam

↑  
stain?

The result of SI measurements  
shows that this spot is flat.

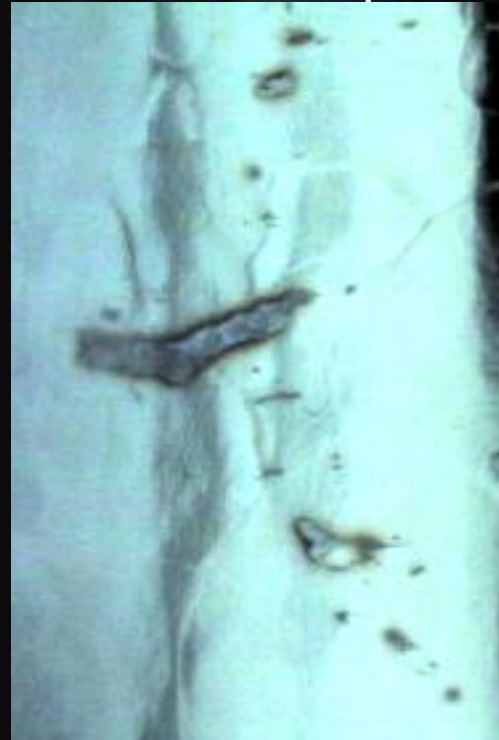
AES001 #2-3 iris 212°

↗  
arc scar?

The result of SI measurements shows that this spot is flat.  
This spots looks like a sign of Field Emission or Arcing.  
Many spots like this were observed.

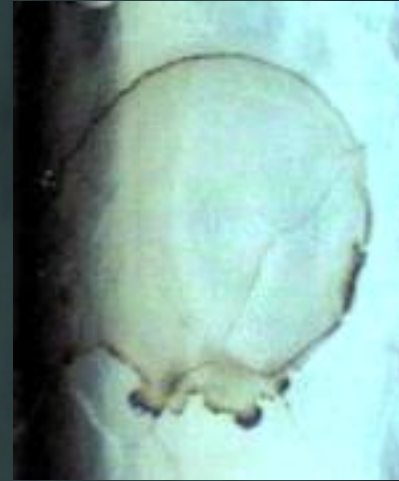
AES001 #4-5 iris 136°

Dropped coffee  
smear?

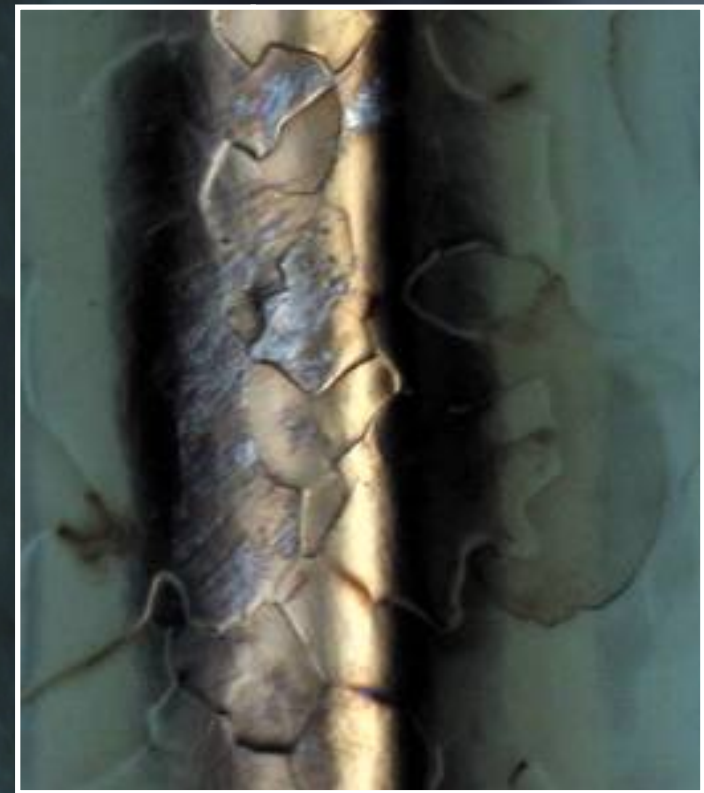
AES001 #7-8 iris 279°

scar?

Dropped  
coffee  
smear?

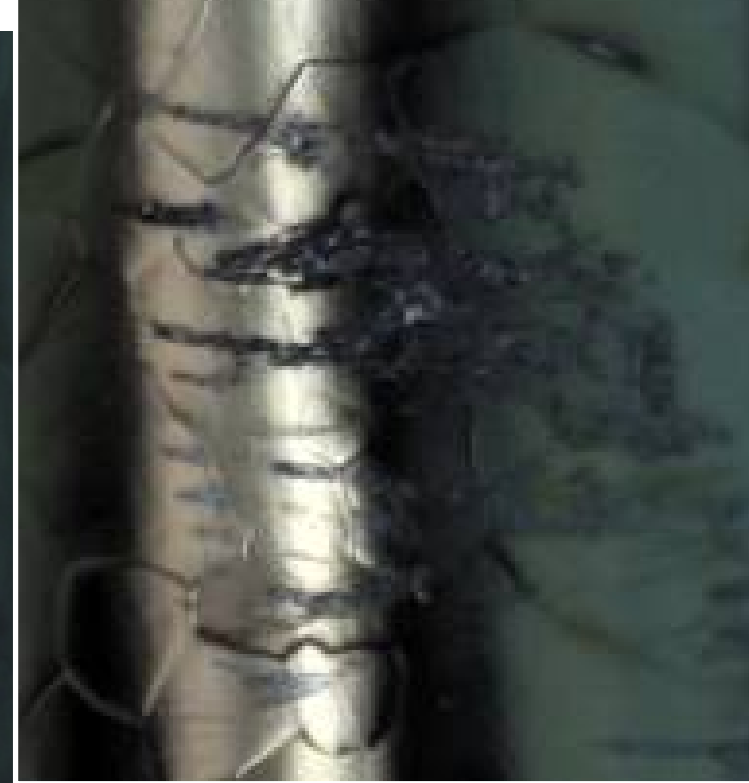
AES001 #8-9 iris 9°

scars?

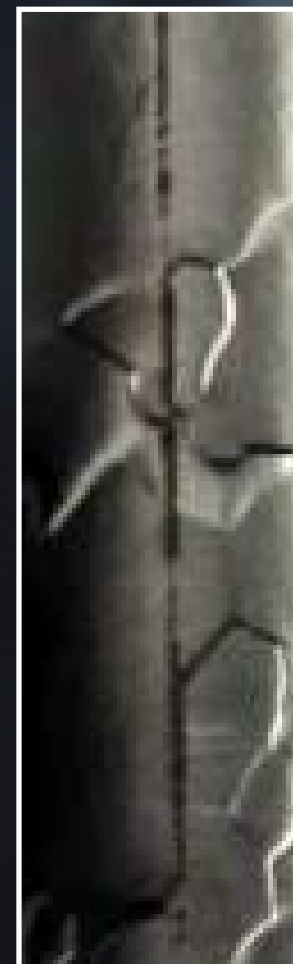
#8-9 iris 82°

crack

- This line was observed, locally at the iris between #8 and #9 cell, and all over the iris between #9 cell and beam tube.
- Niobium was not sufficiently molten during EBW?

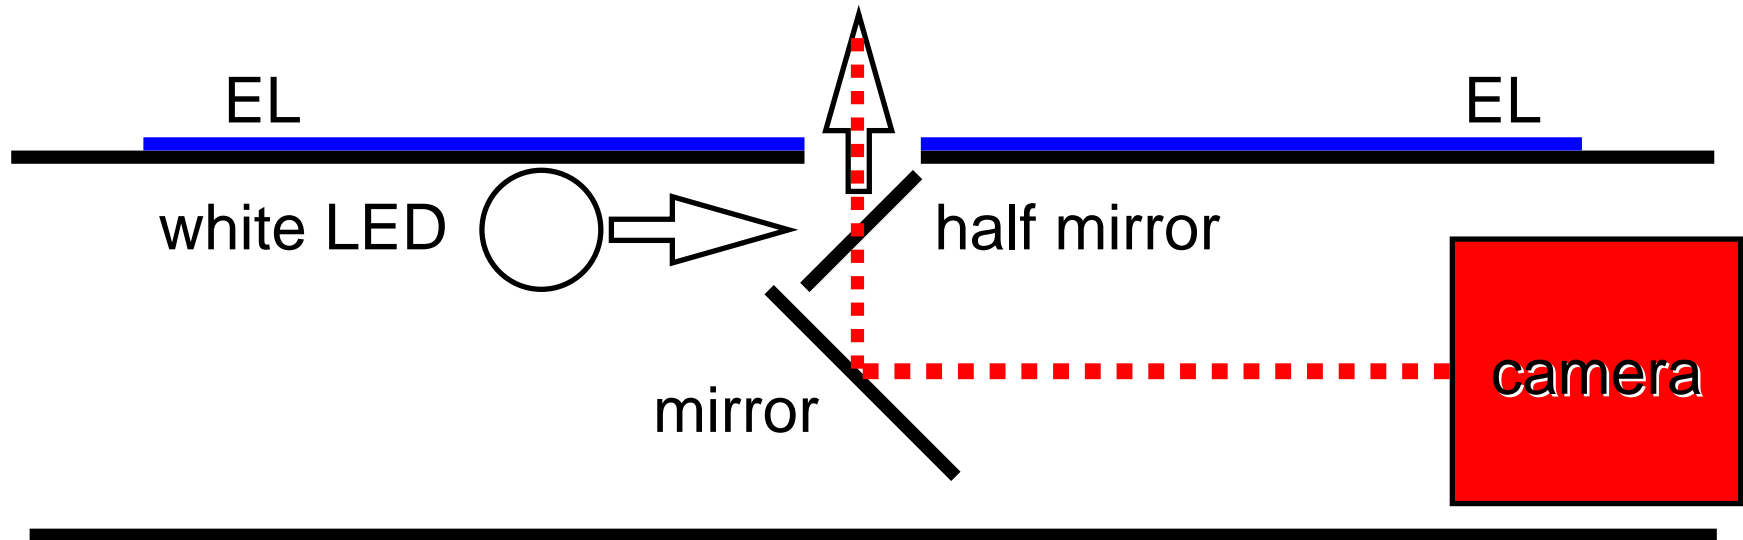
# Illuminating in front of mirror

white LED

mirror

half mirror

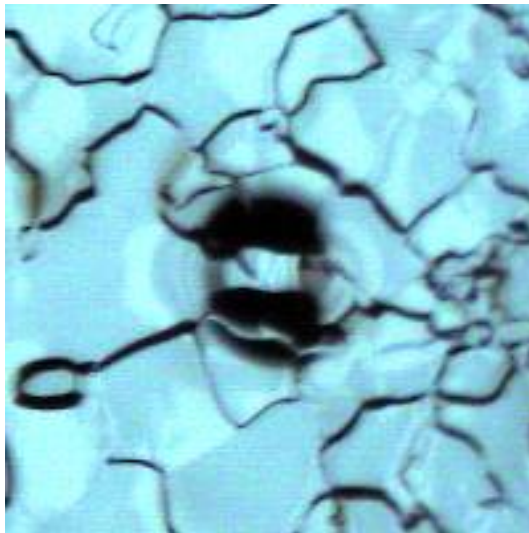
All stripe on  
except center

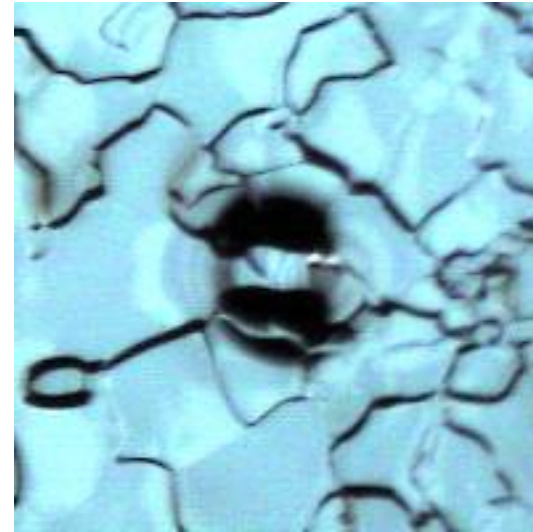
All stripe on
